Final Report on the Investigation of the Macondo Well Blowout

**Deepwater Horizon Study Group
March 1, 2011**

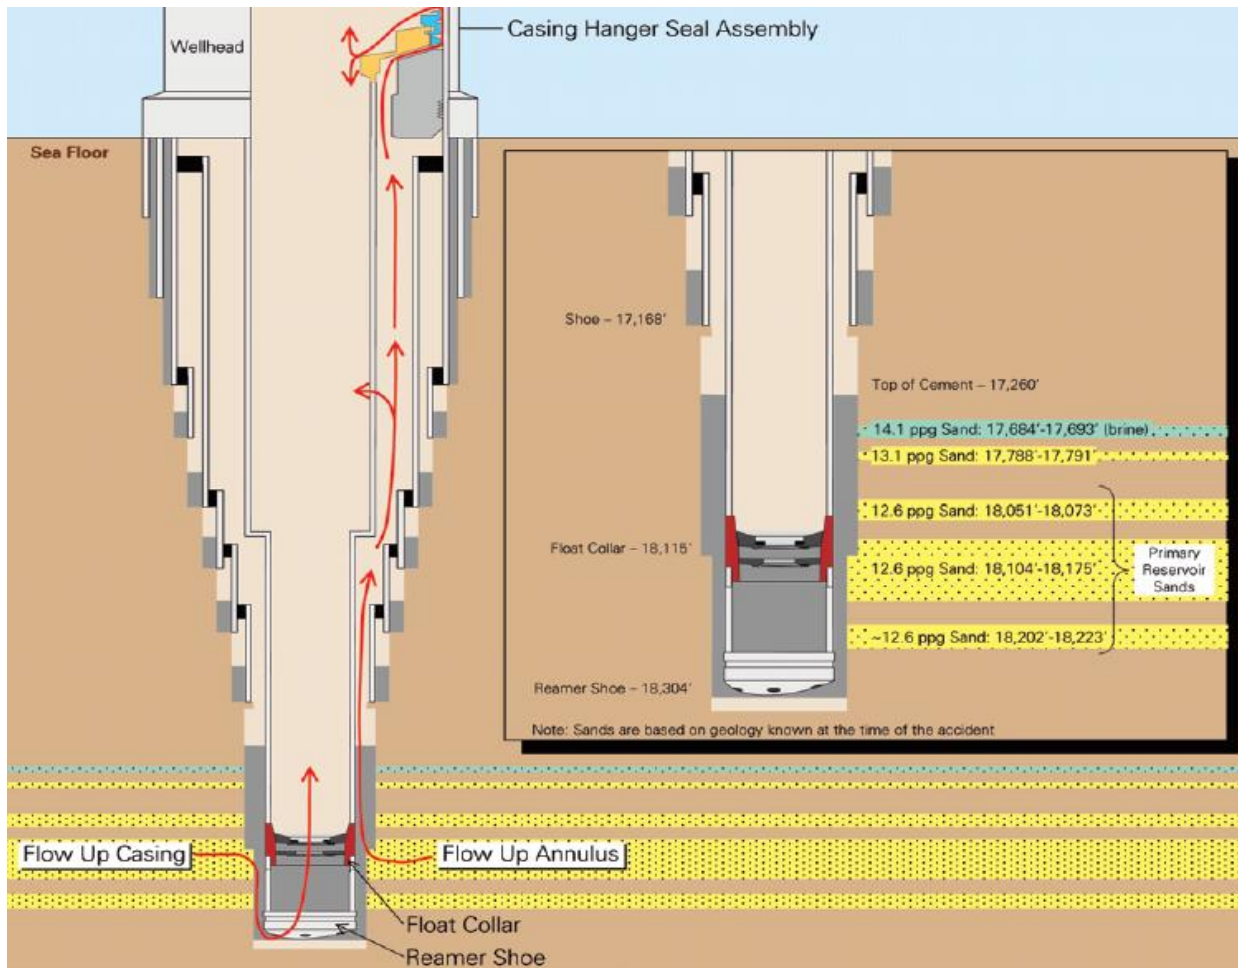
Figure 1.24 – Potential flow paths.¹⁰²

At around 9:08 p.m. the pumps were shut down to allow the sheen test to be performed.¹⁰³ The records indicate that with the pumps off, the drill pipe pressure continued to increase indicating that there was flow into the well.¹⁰³ However it is possible that due to overboard discharge during the sheen test, the inflow could not be directly observed. Following the successful sheen test, at about 9:14 p.m. the pumps were restarted to continue displacement of the spacer fluid overboard, and a spike in pressure occurred when pump #2 was started.¹⁰⁴ The available records of drill pipe pressure show that it continually increased during this period of time.¹⁰⁵ Because of the pumping overboard, there was no method to accurately record the outflow volume.

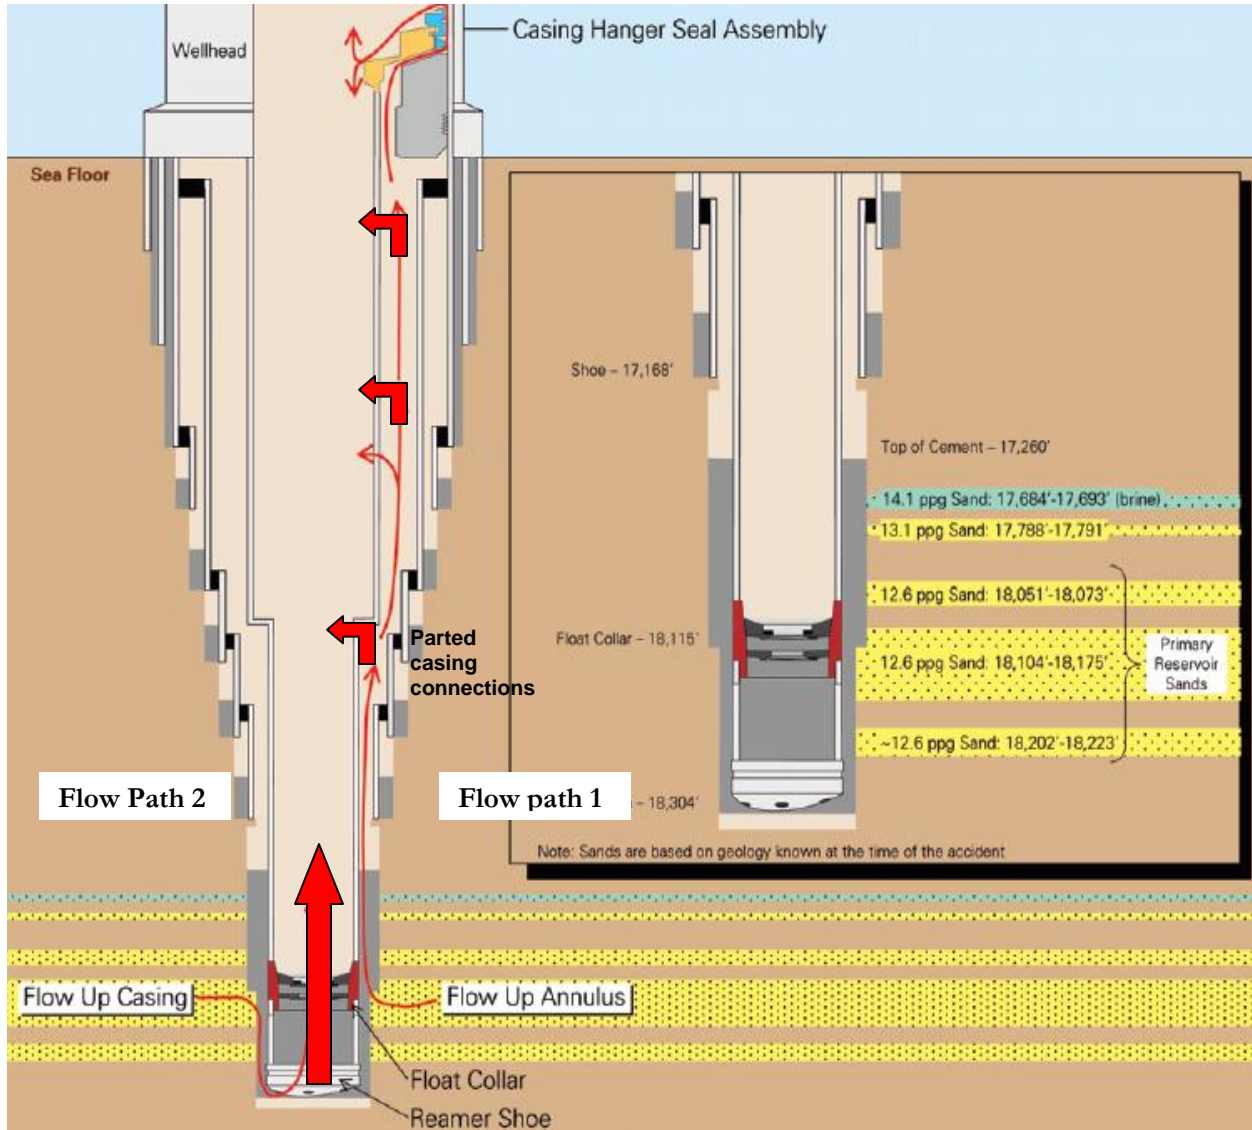
Figure 2.2 - Potential flow paths.¹⁸

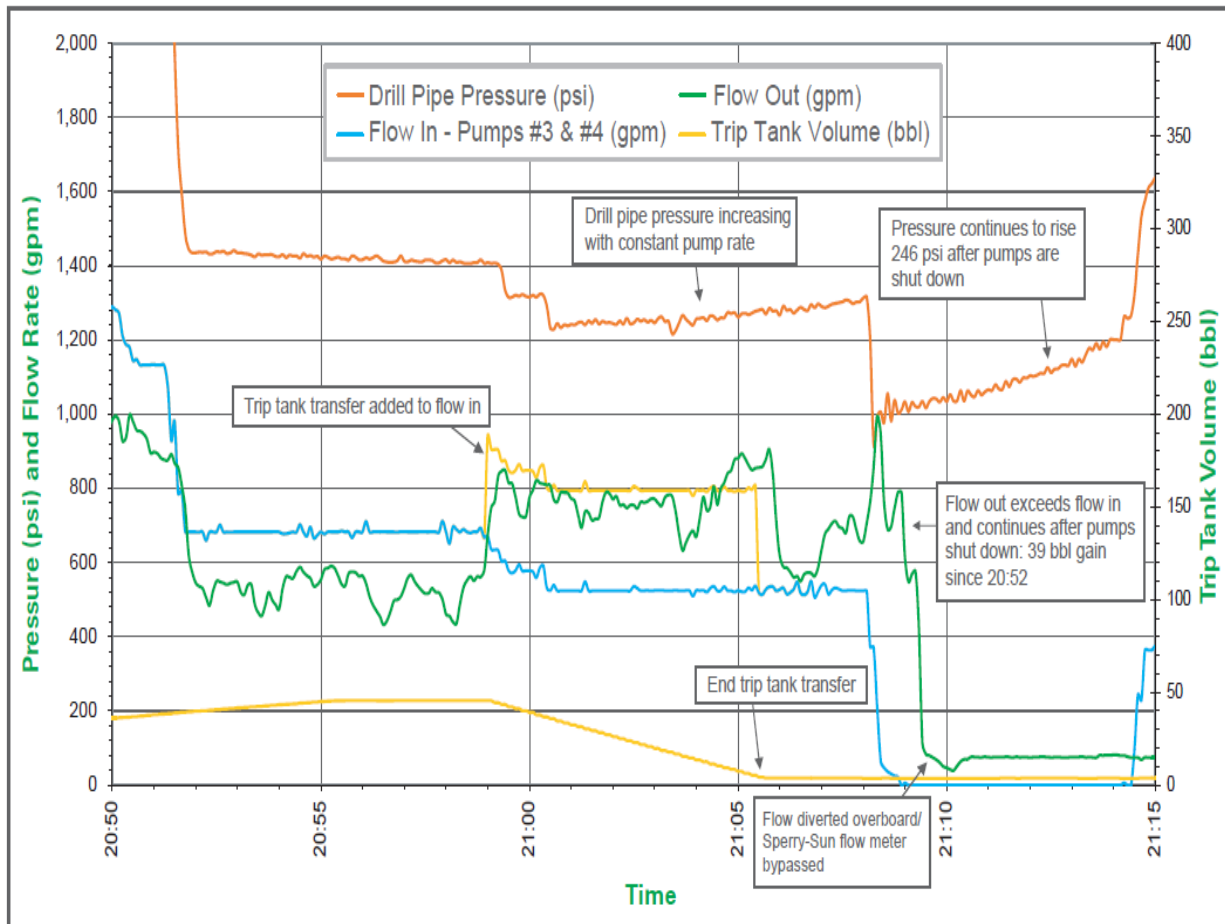
Preparations were also underway to set a cement plug in the well following completion of the displacement operations. Available information and testimony indicates there was no effective monitoring of well flow conditions between about 5:30 p.m. when offloading the mud to the supply vessel began to about 9:00 p.m. (Figure 2.8). The available records indicate the first indication of significant flow from the well would have been shortly before 9:00 p.m. when the well again reached an under balanced condition—the pressures in the reservoir exceeded the pressures in the well bore. The real-time data show the drill pipe pressures were continuing to increase and the flow out exceeded the flow in after the pumps were shut down at 9:08 p.m. Available testimony does not indicate that anyone on the *Deepwater Horizon* recognized these *early warning* signals or took appropriate action to shut in the well.

Figure 2.8 – Real-Time data (April 20, 2010) during last portion of mud transfer operations.³⁵
