**THE BUREAU OF OCEAN ENERGY MANAGEMENT,
REGULATION AND ENFORCEMENT**

**REPORT REGARDING THE CAUSES OF THE APRIL 20, 2010
MACONDO WELL BLOWOUT**

September 14, 2011

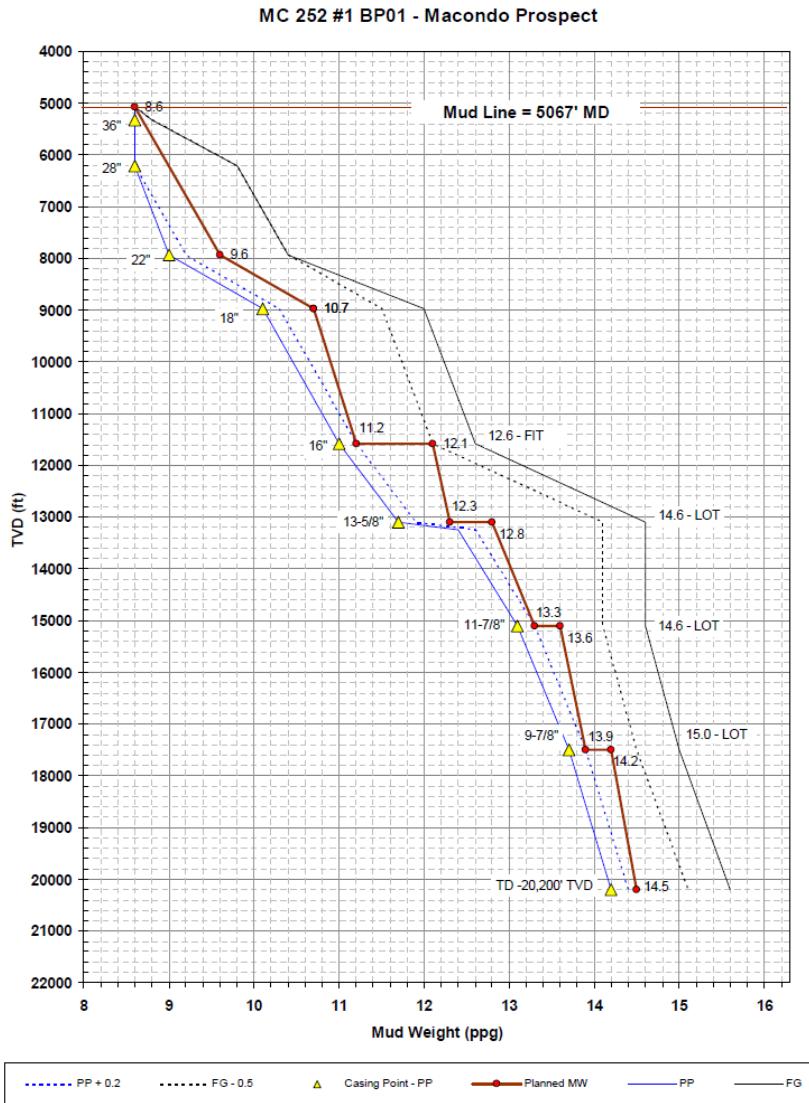
Figure 1 – Macondo Well Pore Pressure Fracture Gradient Plot⁶⁵

The final estimated Macondo well pore pressure, mud weight, and fracture gradient plot submitted to MMS on March 26 is shown at Figure 1. The vertical axis of Figure 1 shows the depth of the well. The horizontal axis shows the mud weight. The red line depicts BP’s planned mud weight, which was designed to be between the kick margin and the swab margin identified in Figure 1.

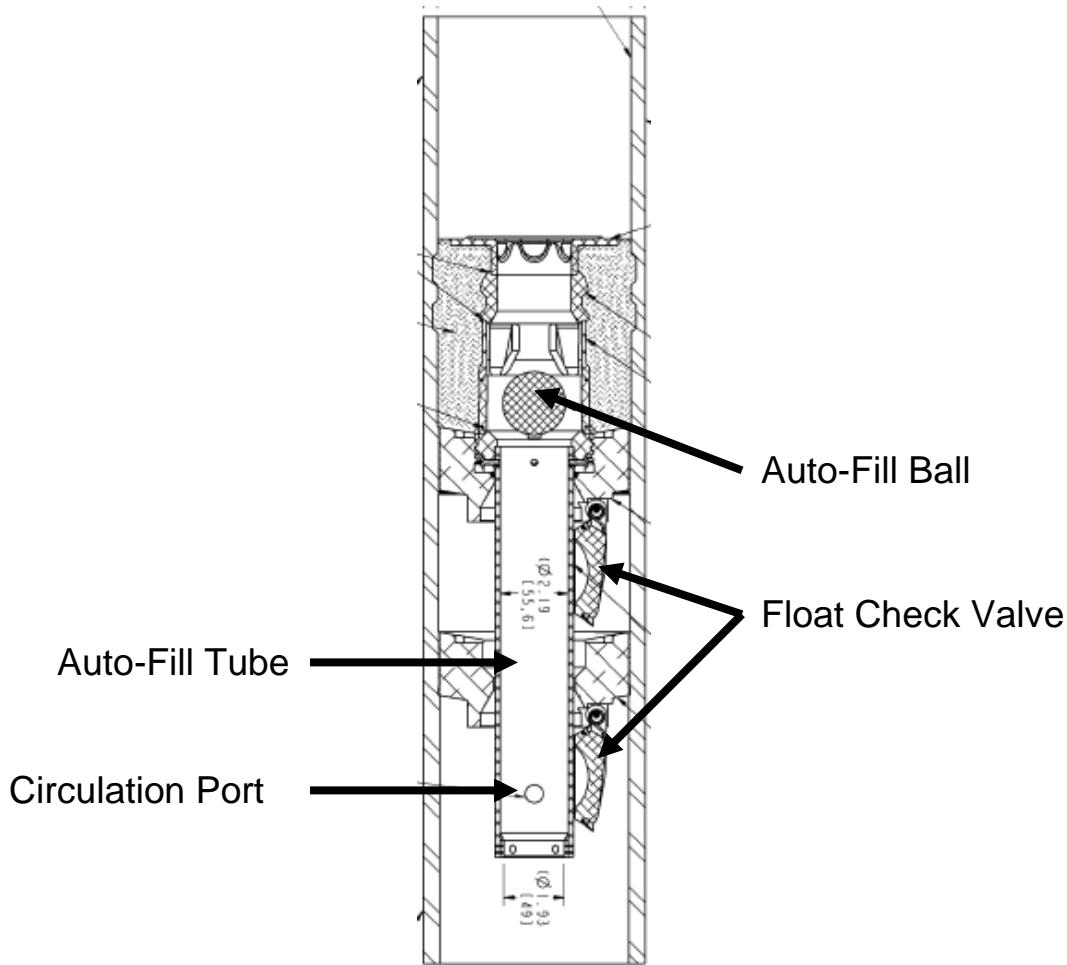
Figure 4 – Float Collar Utilized in the Macondo Well

As discussed above, the float collar was set at 18,115 feet measured depth, within the primary hydrocarbon reservoir sands (see Figure 2, above). Typically, an operator sets the float collar below the primary hydrocarbon sands to allow for perforation of the pay zone without the need to drill out the float equipment to get below the pay zone during the completion of the well. In addition, the lower primary sand was less than 100 feet from the bottom of the production casing shoe.¹¹⁶ Normally, an operator would set the production casing shoe 200 to 300 feet below the primary sand to improve the chances of proper isolation of the pay sand.

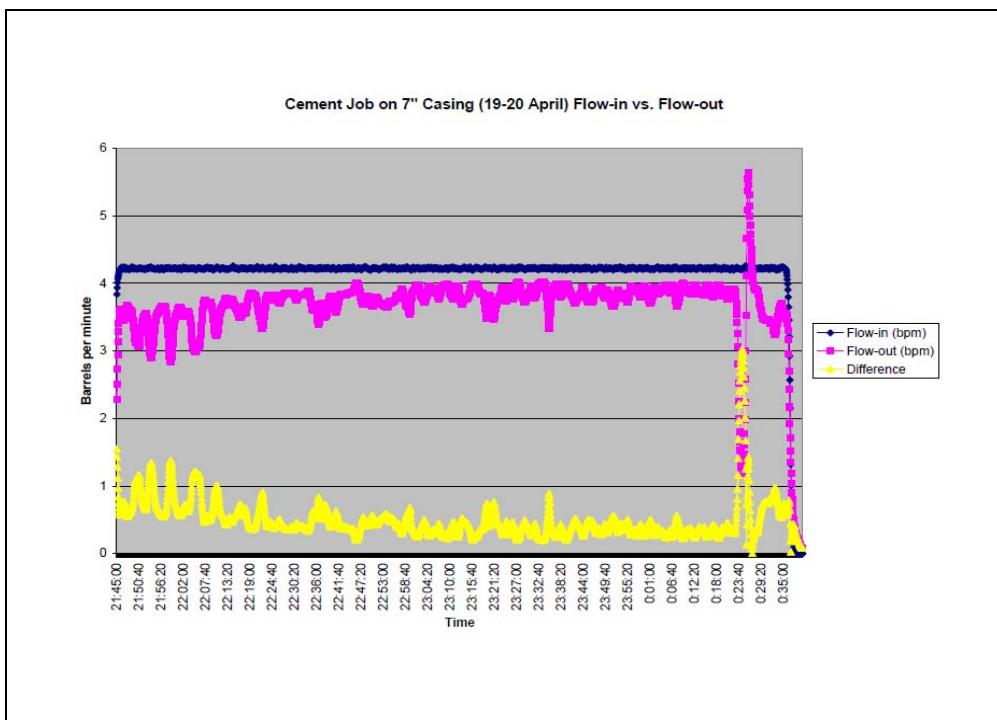
Figure 5 - Flow-out vs. Flow-in on the Production Casing Cement Job (Calculated by Panel)

This possible range of loss exceeded the entire volume of cement pumped during the production casing cement job. This could indicate that over-displacement of cement occurred in the shoe track. In other words, the cement could have been pumped into the well, past the shoe track, which would have left spacer and no cement in the shoe track to isolate the center of the production casing. If over-displacement occurred, it would have resulted in insufficient cement coverage in the shoe track.

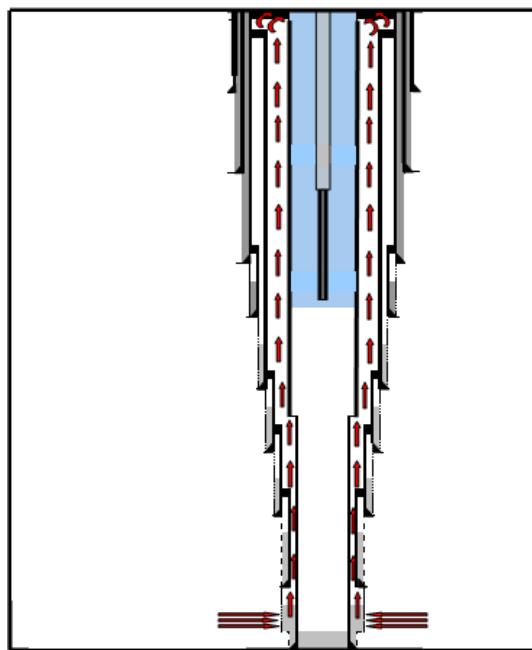
Figure 6 – Flow Up the Annulus and Through the Seal Assembly

Under this scenario, hydrocarbons would have flowed from the reservoir up the backside of the tapered casing string, and through the seal assembly into the riser. If this had occurred, the nitrified annular cement intended to isolate the hydrocarbon zone(s) at the production interval would have failed, the casing would have lifted or floated, and the seal assembly would have failed in conjunction with the casing lifting. This potential flow path is illustrated in Figure 6, below.

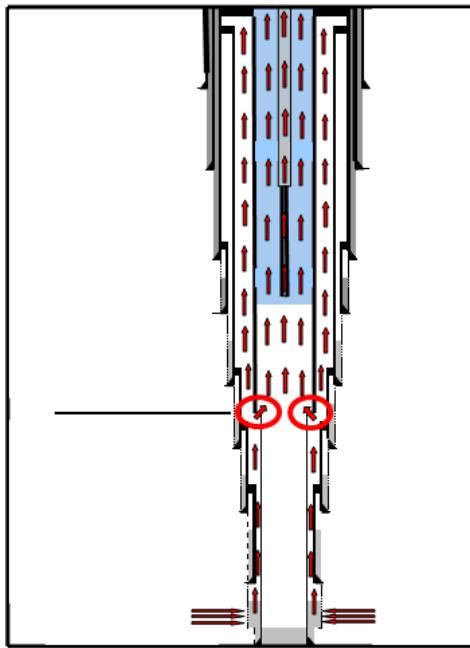
Figure 7 – Flow Up the Annulus and Through Production Casing Crossover Joint

Under this scenario, hydrocarbons would have flowed from the reservoir through the crossover joint of the tapered casing string, into the well and up the riser to the rig. The Panel considered the crossover point to be a possible source of flow because it was manufactured separately from the other tubular elements in the well. If hydrocarbons had flowed in this path, it would mean that the annular cement isolating the hydrocarbon zones at the production interval had failed and the casing had failed at the crossover joint. These failures would have resulted in hydrocarbon flow out of the well and up the riser. This scenario is depicted in Figure 7 below:

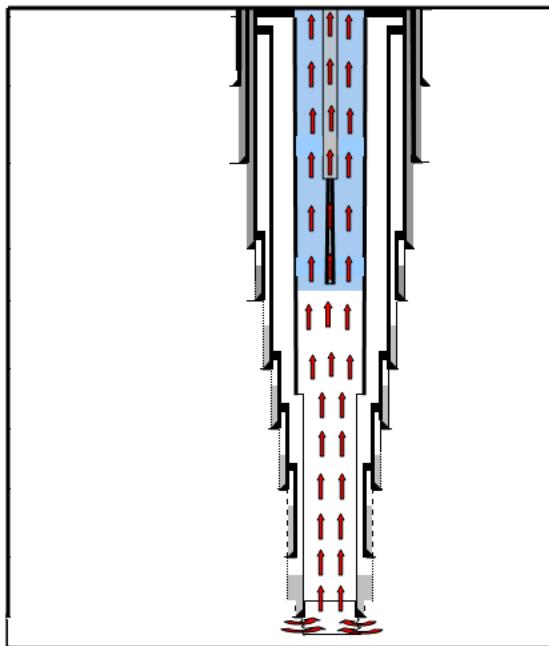
Figure 8 – Flow up the Production Casing Shoe Track

Under this scenario, hydrocarbons would have flowed from the reservoir through the casing shoe, into the well and up the riser to the rig. For this flow path to have occurred, the shoe track cement would have failed. A number of factors could have caused the shoe track cement to fail. First, mud in the wellbore could have contaminated the shoe track cement and caused the cement not to set properly. Second, the shoe track cement might have swapped out with the lighter drilling fluid in the rat hole. Third, some of the shoe track cement could have been lost into the formation. Finally, the failure of the shoe track could have resulted from a combination of these factors. This scenario is represented in Figure 8 below.

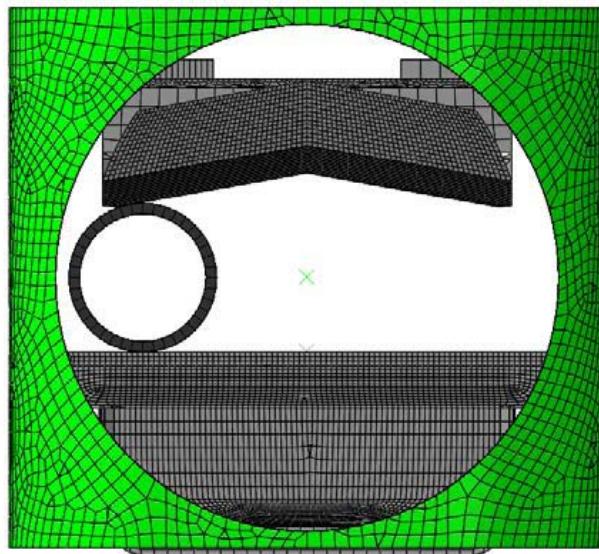
Figure 12 – Off-center drill pipe (Source: DNV)

A forensic examination of the BOP stack revealed that elastic buckling of the drill pipe had forced the drill pipe up against the side of the wellbore and outside the cutting surface of the BSR blades. As a result, the BSR did not completely shear the drill pipe and did not seal the well. The buckling of the drill pipe, which likely occurred at or near the time when control of the well was lost, was caused by the force of the hydrocarbons blowing out of the well; by the weight of the 5,000 feet of drill pipe located in the riser above the BOP forcing the drill pipe down into the BOP stack; or by a combination of both. As a result of the failure of the BSR to completely cut the drill pipe and seal the well, hydrocarbons continued to flow after the blowout.
