EPRI Independent Peer Review of the TEPCO Seismic Walkdown and Evaluation of the Kashiwazaki-Kariwa Nuclear Power Plants

A Study in Response to the July 16, 2007, NCO Earthquake

Independent Peer Review, January 2008

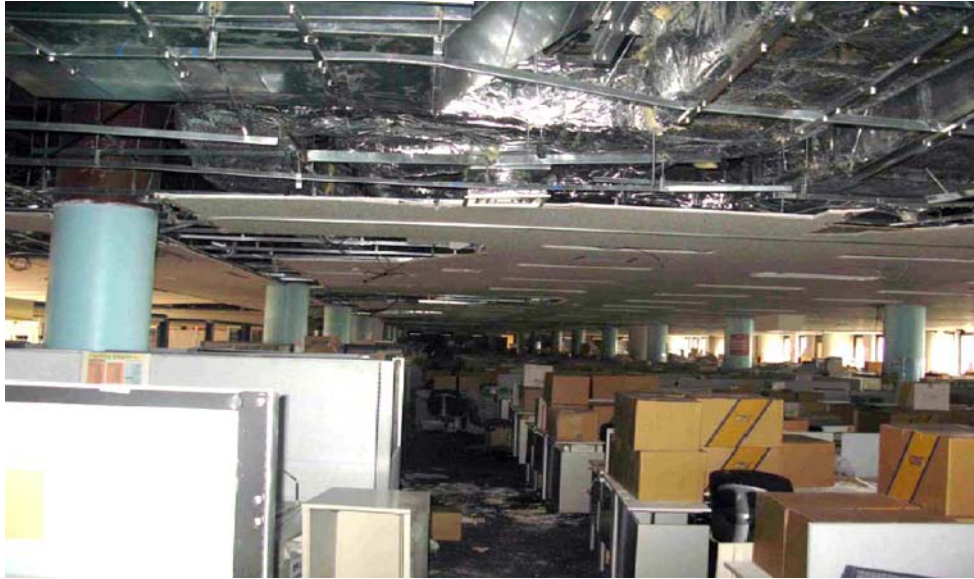
- The failure/falling of suspended ceiling panels and light fixtures and the breakage of a glass wall partition were reported by TEPCO in NSR structures such as the Administration Building. Un-anchored equipment such as computers fell from desks and documents/books generally fell from their shelves. The access door to the Technical Support Center in the Administrative Building was stuck shut for about 45 minutes following the earthquake, preventing access of personnel to the instrumentation and communication equipment in the Center.

Figure 4-1
Ceiling Damage in Administration Building

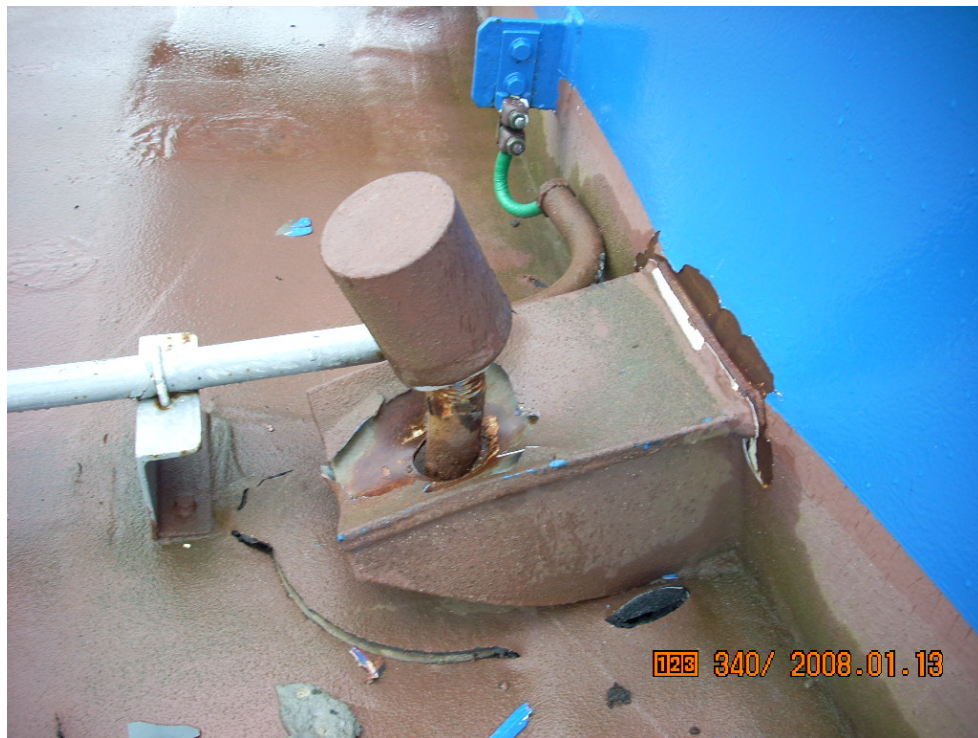
Figure 4-2
Damage to Domestic Water Tank Anchorage in KK Plant Yard

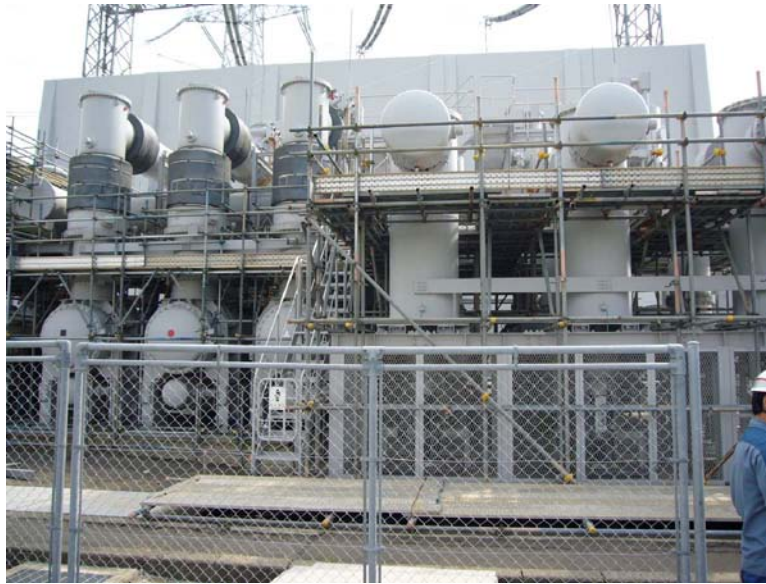
Figure 4-3
Vast Majority of Switchyard Exhibited No Damage

In summary, it is considered significant that off-site power was maintained during and after the earthquake in two of four lines, despite the fact that this switchyard is not safety related. This positive performance is not consistent with the experience at other non-nuclear facilities which experienced strong earthquakes. This may be attributed to the fact that the main switchyard foundation and equipment anchorages were reportedly designed for 0.2 g static acceleration. This observation supports a conclusion that this system demonstrates substantial margin compared to its reported seismic design basis.

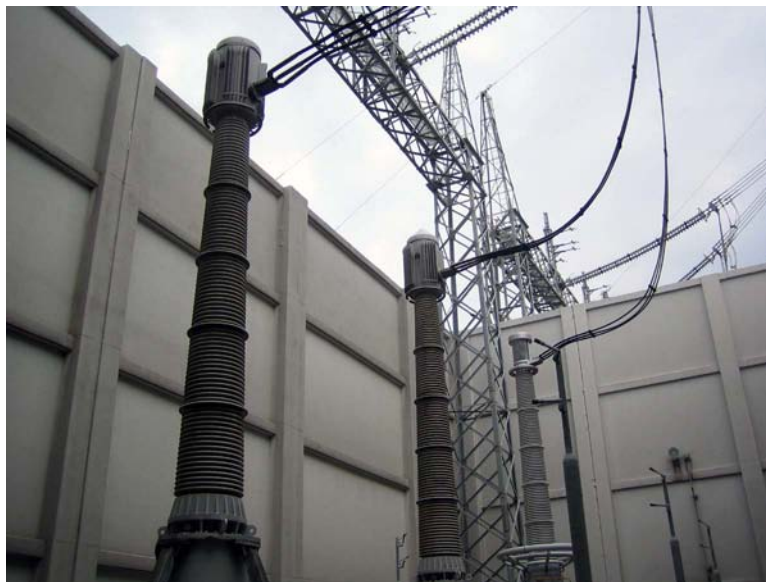
Figure 4-4
Bushing Plate Junction to Termination Stack

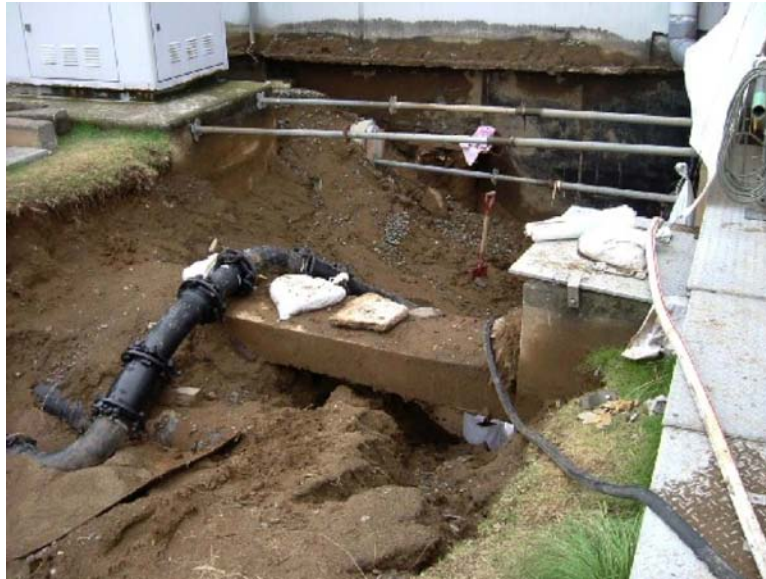
Extensive soil failures occurred over the Kashiwazaki-Kariwa plant site. Generally, these failures caused direct or indirect failures of Safety Class C items only. In some cases, soil failure led indirectly to consequences, which were reportable events (see Sec. 4.2.1.1, Table 4-1 for TEPCO definition of reportable events). One important example was the failure of the underground fire suppression piping on the west side of the Unit 1 reactor building. This piping failure was caused by soil failure in the immediate vicinity. It led to water and soil flowing into the reactor building through cable penetrations and subsequently flowing in the reactor building from grade elevation to the top of the foundation at B5F or about 45 meters below grade. In other cases, soil failure

led to consequences such as relative displacements between segments of foundations of structures or components, e.g., Unit 1 CWP Pump House relative deformation between the three foundation segments, Unit 3 house transformer leading to fire, Units 1-5 main stack ducts excessive displacements. Further, soil failures disrupted infrastructure within the plant site boundaries, e.g., roads, walkways, stairs, etc.

Figure 4-5
Failure of Underground Piping

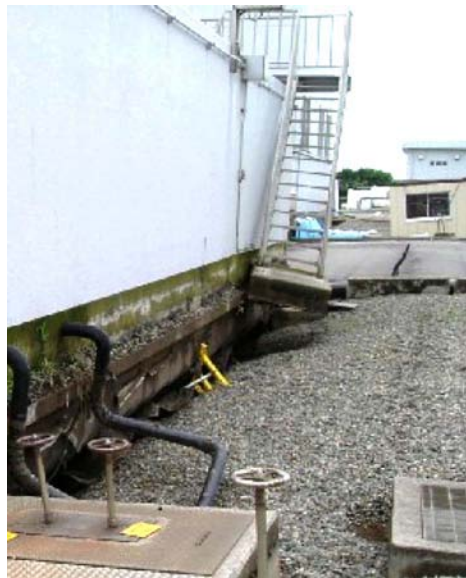
Figure 4-6
Ground Subsidence at Fuel Oil Tank

Soil failures occurred in the non-Safety areas of the plant, i.e. Class As, A, or B structures systems and components were not directly affected by the soil failures. The impact to Safety Class As, A, or B structures or components was minor with the exception of the indirect effect on the Unit 1 reactor building described above. For all units, the major Safety Class As, A, and B structures are founded at significant depths (ranging to about 45 meters below grade for the reactor buildings). This design feature was deemed by the EPRI Peer Review Team to be very beneficial in terms of the dynamic response of the structures and in the absence of soil failure-related consequences to these buildings and the systems housed therein.

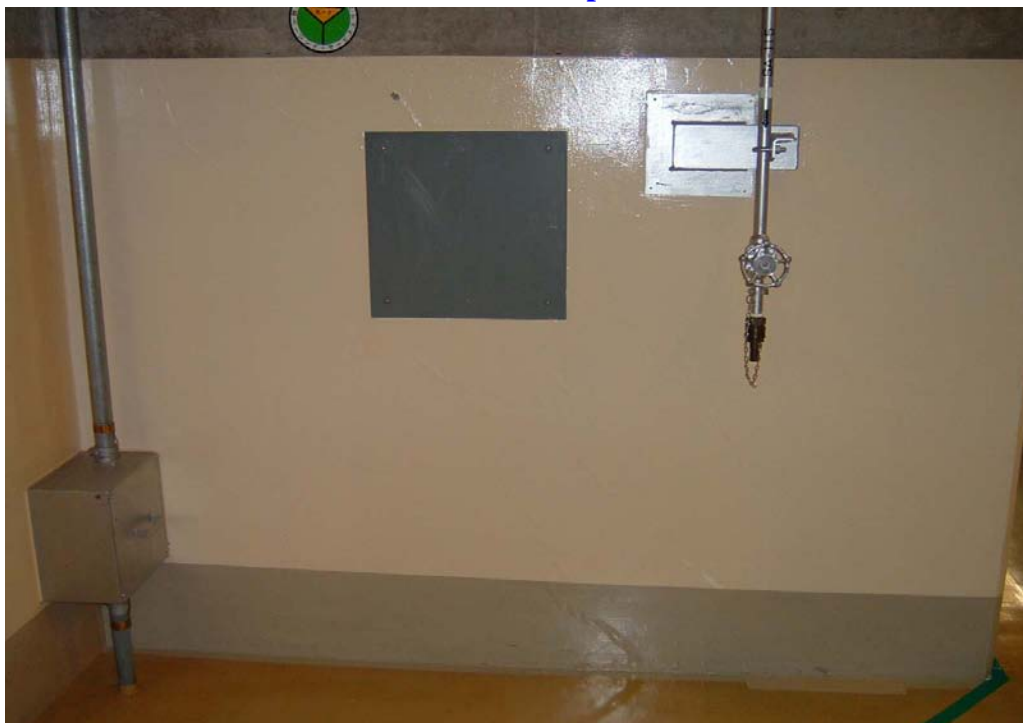
DSCF0010 – Diagonal Cracks East Wall

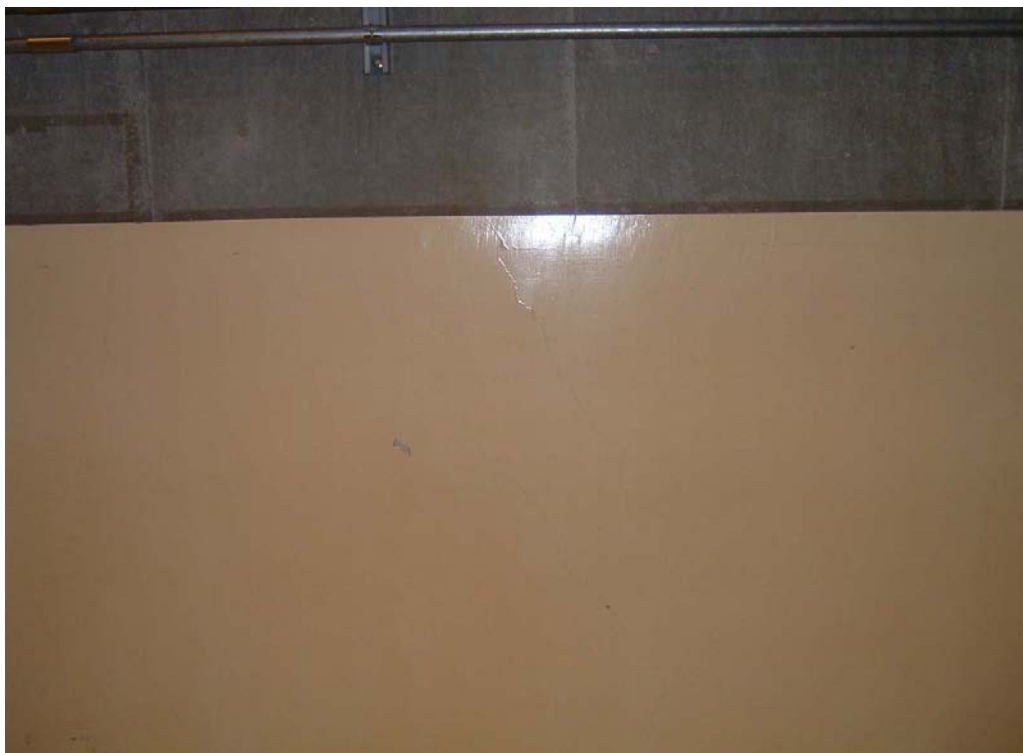
DSCF0011 –Diagonal Cracks – North Wall
