**SUBJECT: MITSUBISHI HEAVY INDUSTRIES – REQUEST FOR WITHHOLDING ROOT CAUSE ANALYSIS AND SUPPLEMENTAL TECHNICAL EVALUATION REPORT INFORMATION FROM PUBLIC DISCLOSURE**

**Root Cause Analysis Report for tube wear  
identified in the Unit 2 and Unit 3 Steam Generators of  
San Onofre Nuclear Generating Station**

On January 31, 2012, after the replacement steam generators (RSGs) supplied by MHI had been operating for approximately 11 months, SONGS Unit 3 was brought into an unplanned shutdown due to primary to secondary leakage of approximately 82 gallons/day in one RSG. The direct cause of the leakage was determined to be tube to tube wear in the free span section of the U-bend region of the RSG, leading to a leak from one of the tubes in that region.

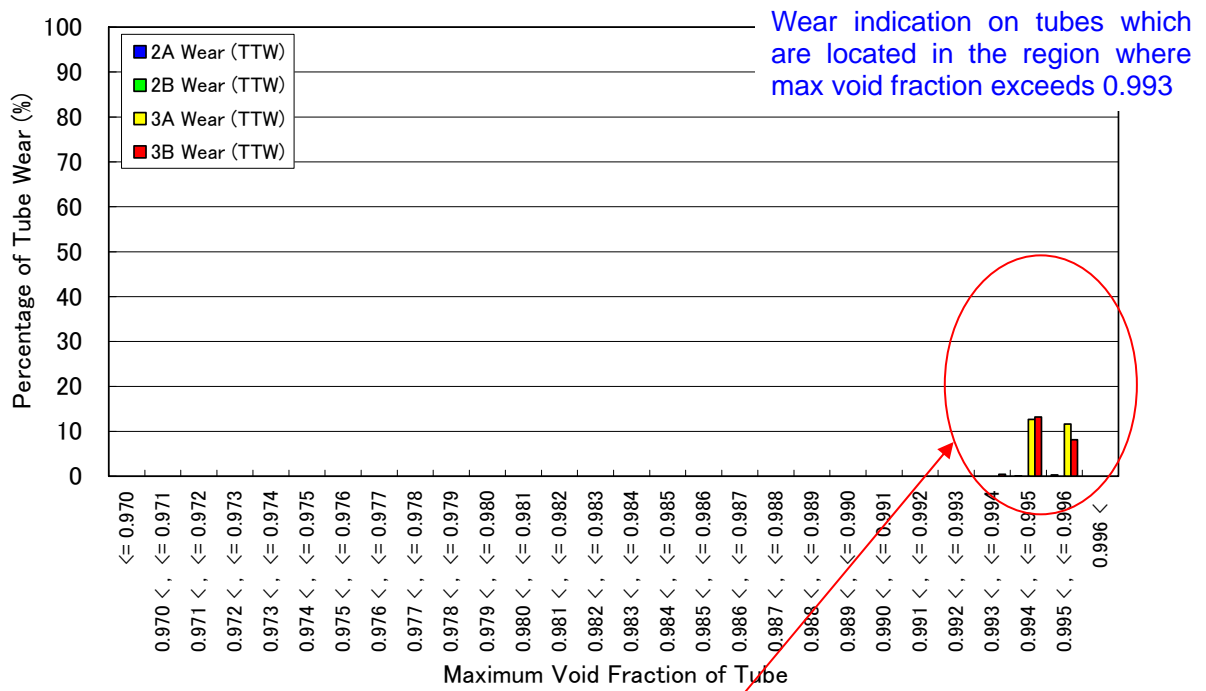
Fig. 2.3.4-4 shows the correlation between void fraction and steam quality with the percentage of tubes at different levels of void fraction and steam quality that have Type 1 wear. The 328 tubes that had Type 1 wear fall within the region of steam quality of [ ] to [ ] and void fraction of [ ] to 0.996. However, less than [ ] of the Unit 3 tubes in this region of high steam quality and high void fraction have Type 1 wear. Fig. 2.3.4-4 displays the same data as shown in Fig. 5.1-2 in the TER (Ref. 1). The TER (Ref. 1) also discusses the relationship between high velocity and Type 1 wear for which the correlation is not as strong.

Strong correlation between the number of tubes with wear and void fraction (steam quality)

Fig.2.3.4-4 Correlation between Type 1 Wear (TTW) and Void Fraction (Steam Quality)

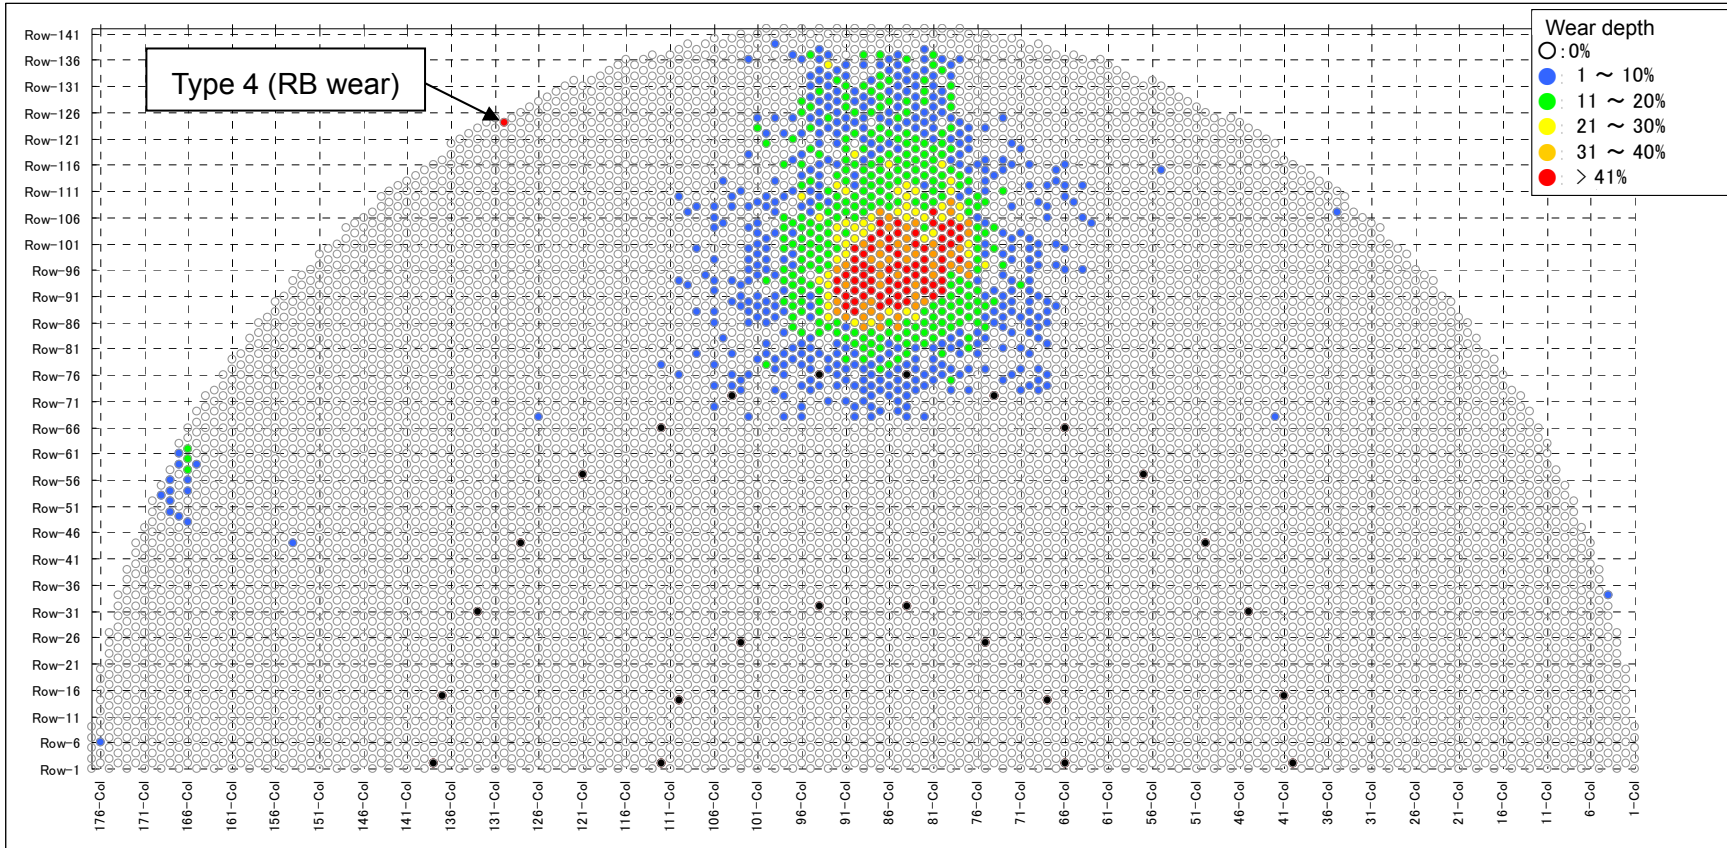
Fig 3.1-2 (1/2) All Unit 3 U-bend tube indications  
(Type 1 TTW, Type 2 Tube-to-AVB and Type 4 Retainer Bar to Tube)
