Final Report on the Investigation of the Macondo Well Blowout

**Deepwater Horizon Study Group
March 1, 2011**

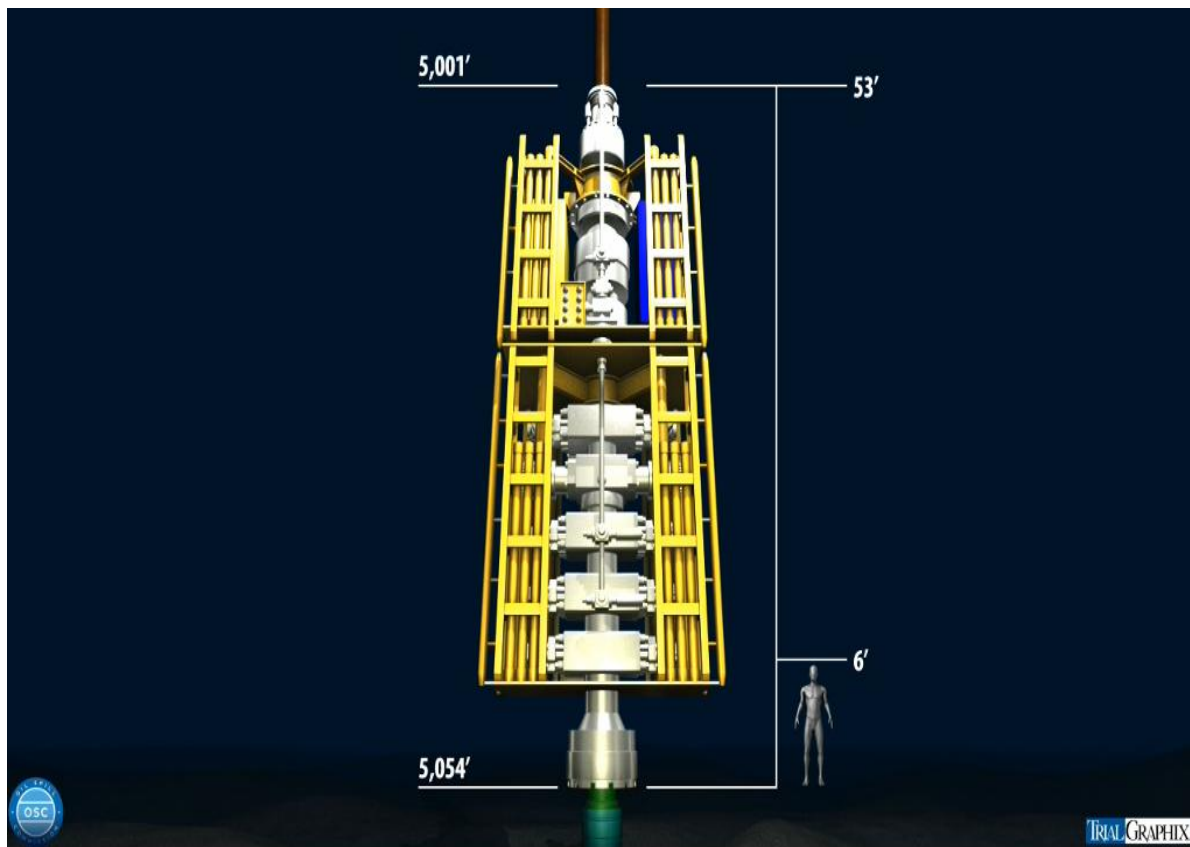
Figure 1.7 – Blowout Preventer (BOP).²⁶

At the depth and pressures encountered by the *Deepwater Horizon* well, MMS regulations require at least four remote-controlled, hydraulically operated valves, or rams during offshore operations.²⁵ All of the rams on the BOP failed to close properly during the blowout event that occurred on the *Deepwater Horizon*.

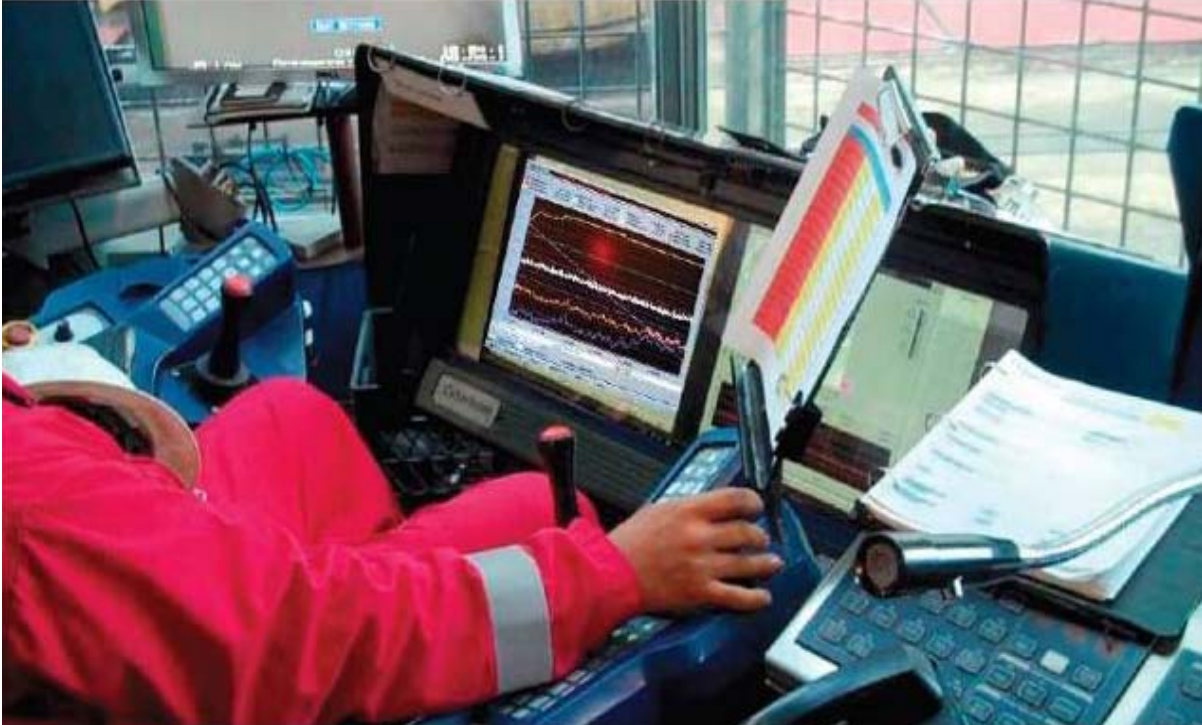
Figure 1.21 – View of the driller's data-panel.⁹⁹

April 20, 9:00 p.m. – Shortly after 9:00 p.m. pressure on the drill pipe increased from 1,250 psi to 1,350 psi. The drill pipe pressure should have decreased due to the removal of the heavier mud (14.7 ppg) and its replacement with the lighter weight seawater (8.6 ppg). This abnormality could have been detected from monitoring the drill pipe pressure data, and could have been the first clear indication of the flow of hydrocarbons into the well, visible to the crew.⁹⁸ Spacer fluid was then observed at the surface.

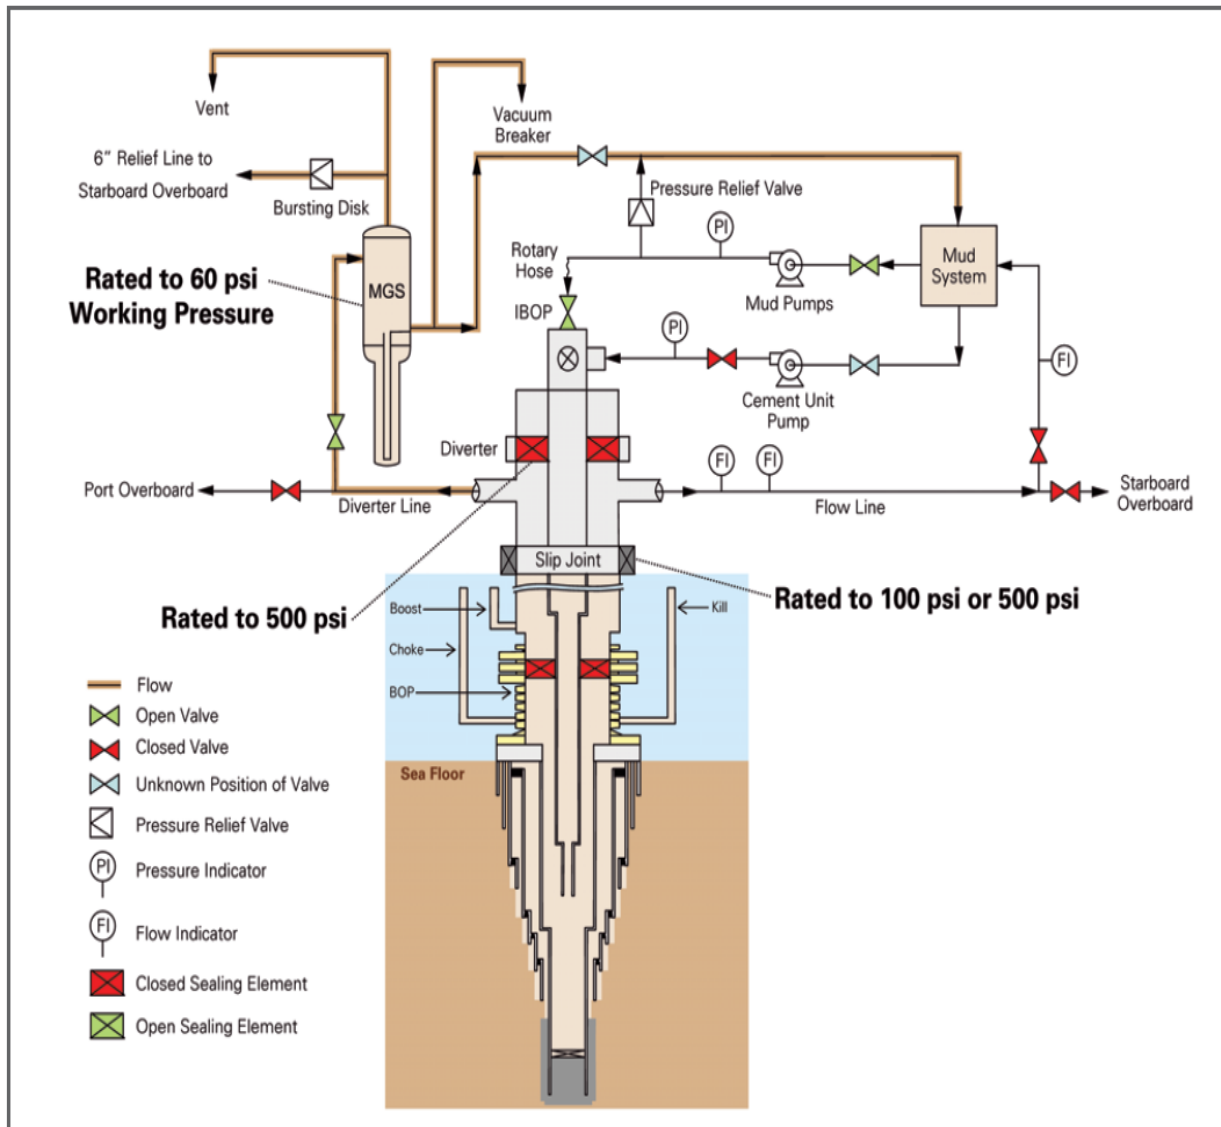
Figure 2.11 – Schematic of *Deepwater Horizon* surface equipment.³⁹

After about 9:40 p.m., the drill pipe pressure increased from about 340 psi and reached 1,200 psi about 9:47 p.m. (Figure 2.10). Testimony indicates that by about 9:47 p.m. seawater and mud were shooting up through the derrick, and shortly thereafter the diverter was closed and flow from the riser was routed to the mud gas separator (MGS) (Figure 2.11 and Figure 2.12).

Subsequent hydrocarbon flow could have developed through the drill pipe inside the riser. There are a number of pieces of equipment that could have failed and allowed hydrocarbons to flow to the surface through the drill pipe (Figure 2.11) thereafter. Also, flow could have developed outside of the drill pipe (Figure 2.13). Following loss of power, the rig dynamic positioning system was inoperable. Rig drift-off following the loss of power could have caused the drill pipe to be pulled through the BOP destroying the annular seal and allowing resumption of flow up the riser. Analysis

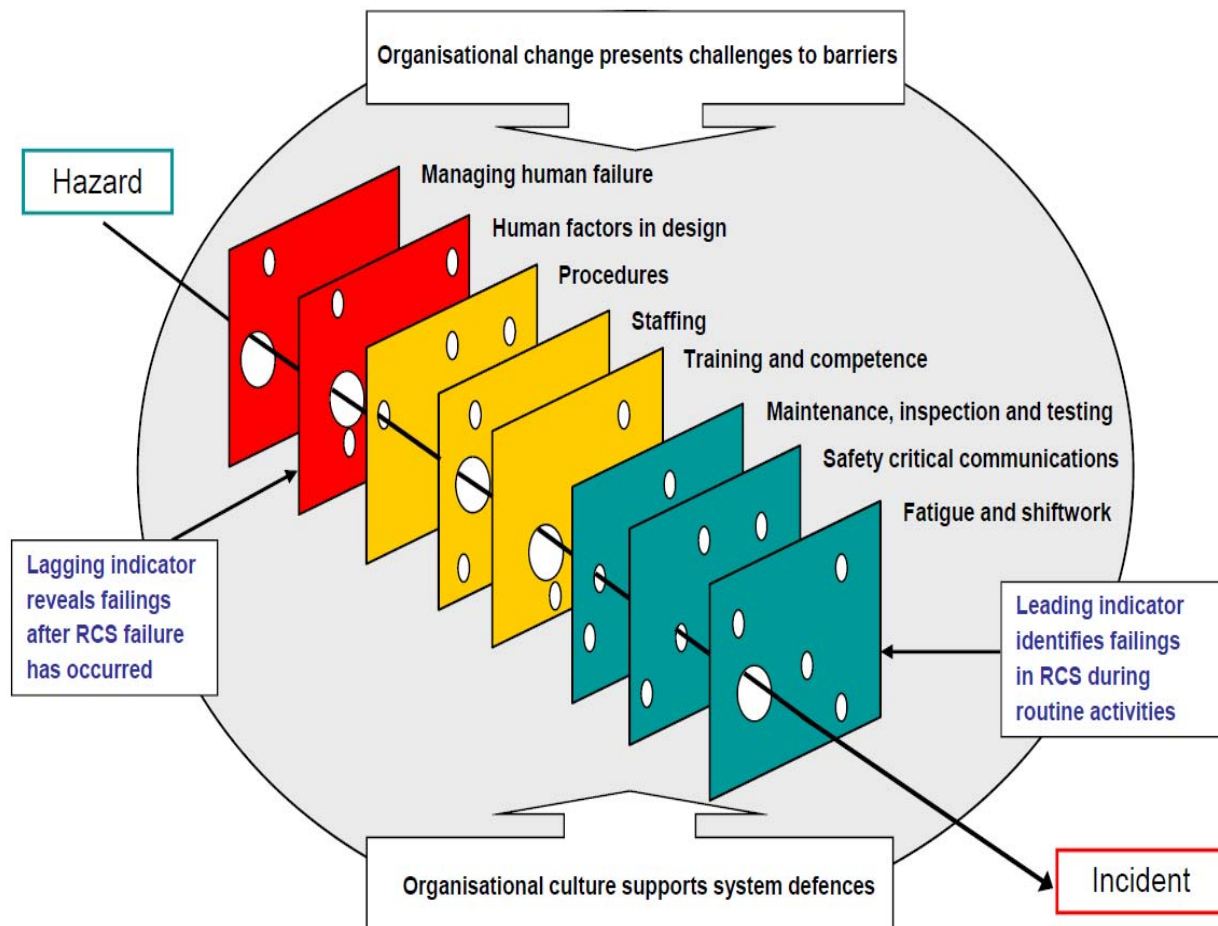
Figure 3.1 – Accident resulting from successful penetration of multiple defensive barriers.⁴

A useful metaphorical perspective that can be applied to the Macondo well disaster has been developed by James Reason. Reason’s *Managing the Risks of Organizational Accidents Theory* (OAT)³ describes major system *organizational* accidents as penetration of hazards through the system’s defenses or *barriers*. In Reason’s ‘Swiss Cheese’ model (Figure 3.1), an accident develops when the major hazards confronting a system are able to successfully penetrate the barriers through aligned *holes* (defects, deficiencies) in the barriers formed by the Risk Control System (RCS).

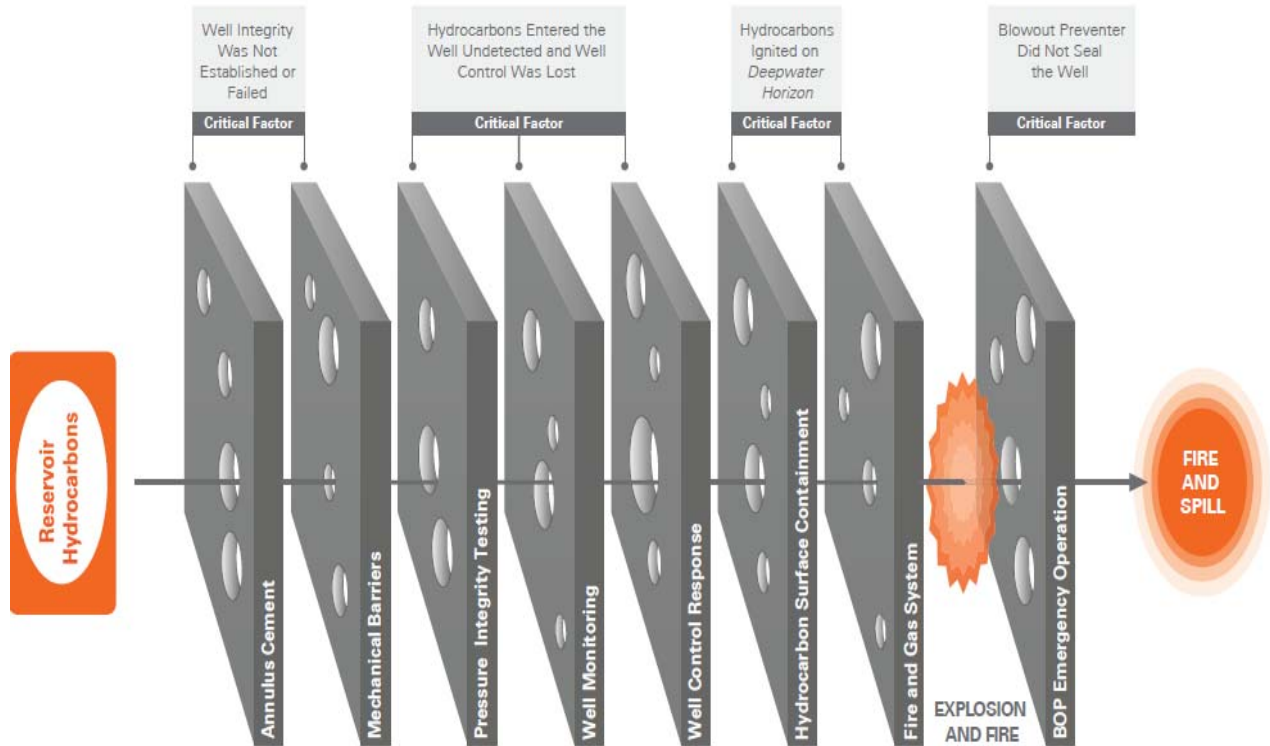
Figure 3.2 – BP’s analysis of defensive barrier penetration leading to the Macondo blowout.⁷

There were critical defects embedded in BP’s defensive barrier system prior to the initiation of the failures including those associated with the design and construction of the long-string completion system with the *iffy* barriers.⁸ Another example is related to the *sketchy* negative test procedure sent by BP to the *Deepwater Horizon* on the morning of April 20, 2010. The procedure was a high hazard process in which a critical test was performed with minimal passive and active barriers. No definitive guidance, however, was designed or provided for interpretation of data derived from the negative tests or prescribed the corrective action required if the negative tests did not provide assurance that the well *pressure vessel* was intact. Evidence indicates that the drilling crew had not received any formal training in performing this critical test.
