EPRI Independent Peer Review of the TEPCO Seismic Walkdown and Evaluation of the Kashiwazaki-Kariwa Nuclear Power Plants

A Study in Response to the July 16, 2007, NCO Earthquake

Independent Peer Review, January 2008

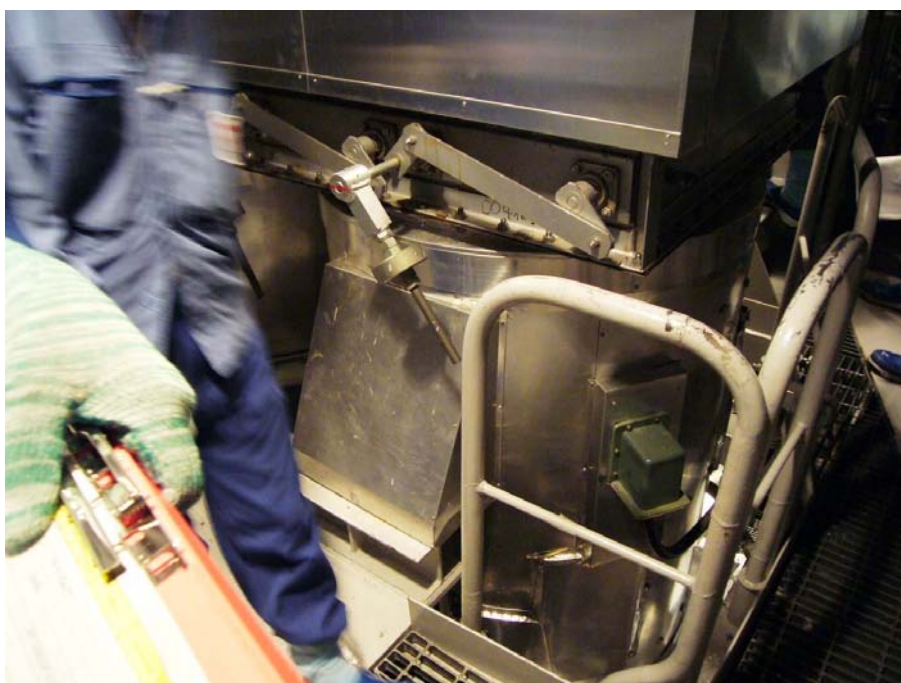
P1040485 (11-1b)

1. Check equipment anchorage/isolation mounts for damage; e.g., stretching or loosening of anchor bolts or nuts; rocking or sliding of equipment. ☒
Comments: No isolation mounts, rugged anchorage

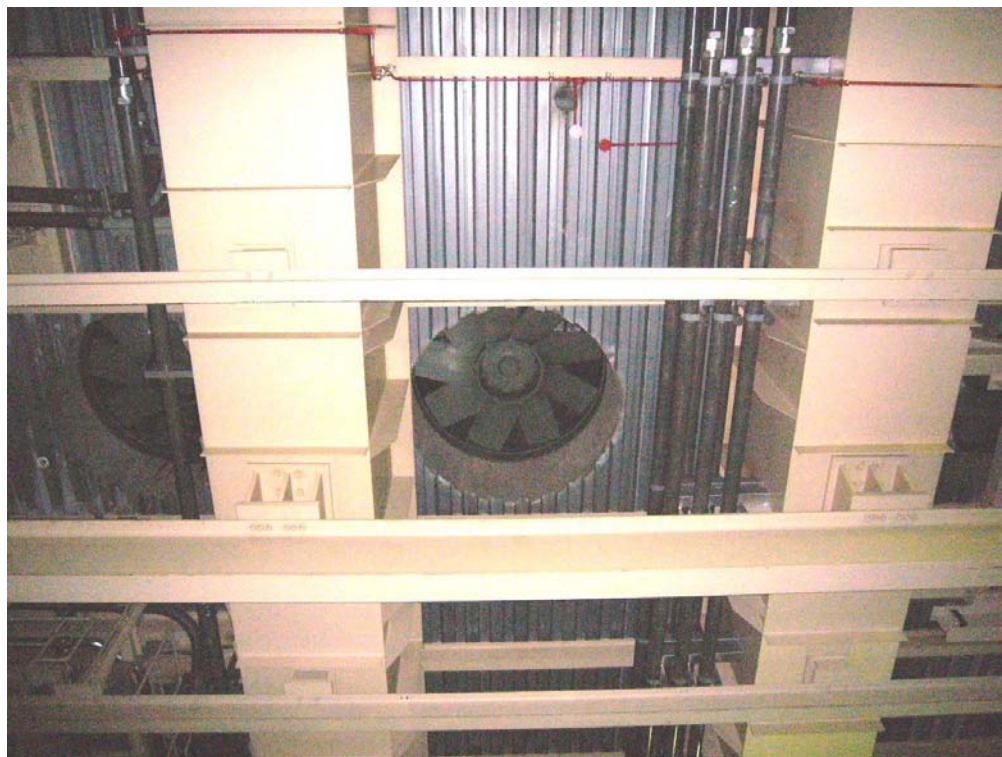
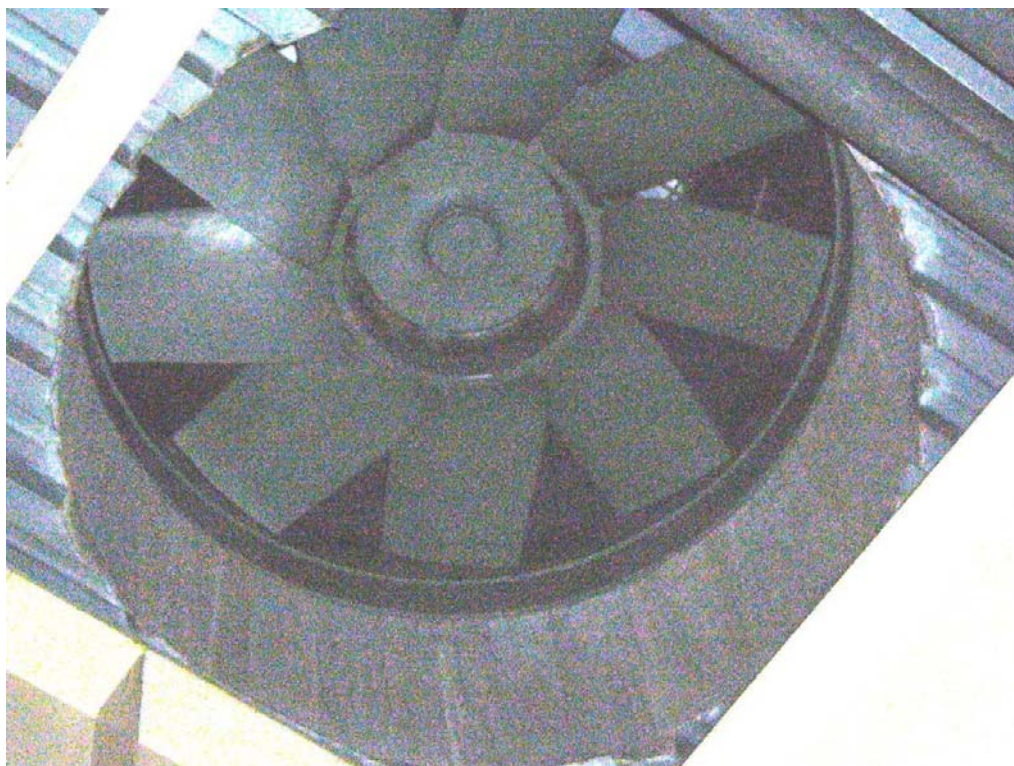
Walkdown Notes/Comments: Undisturbed condition. NVD
displacement.

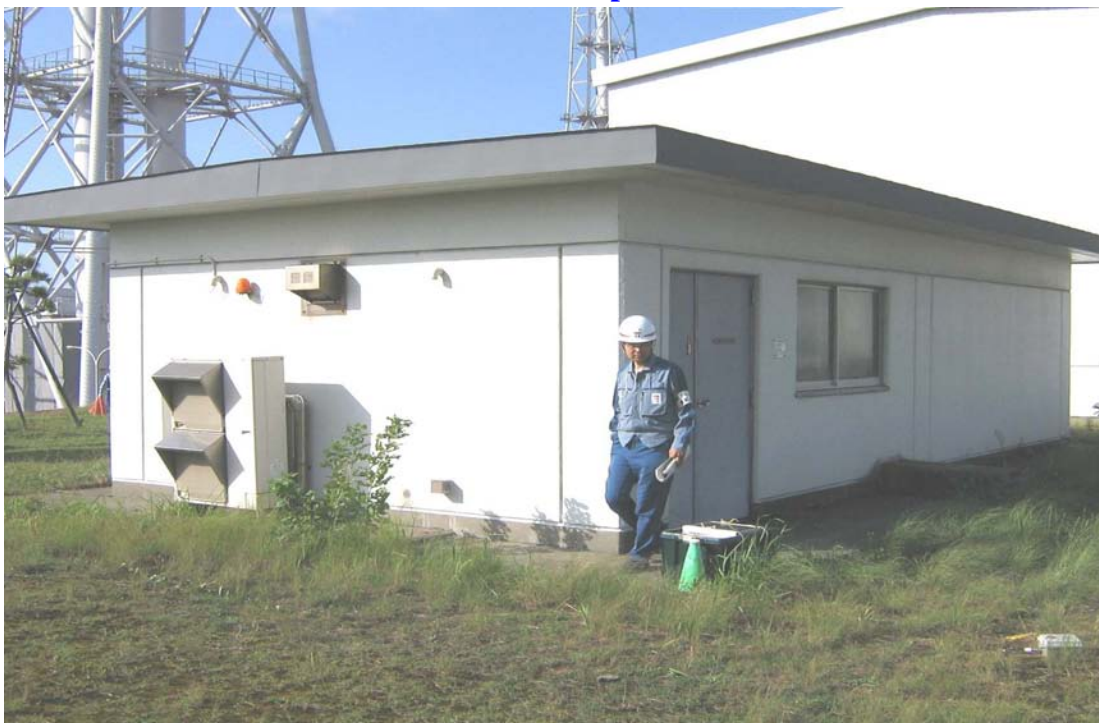
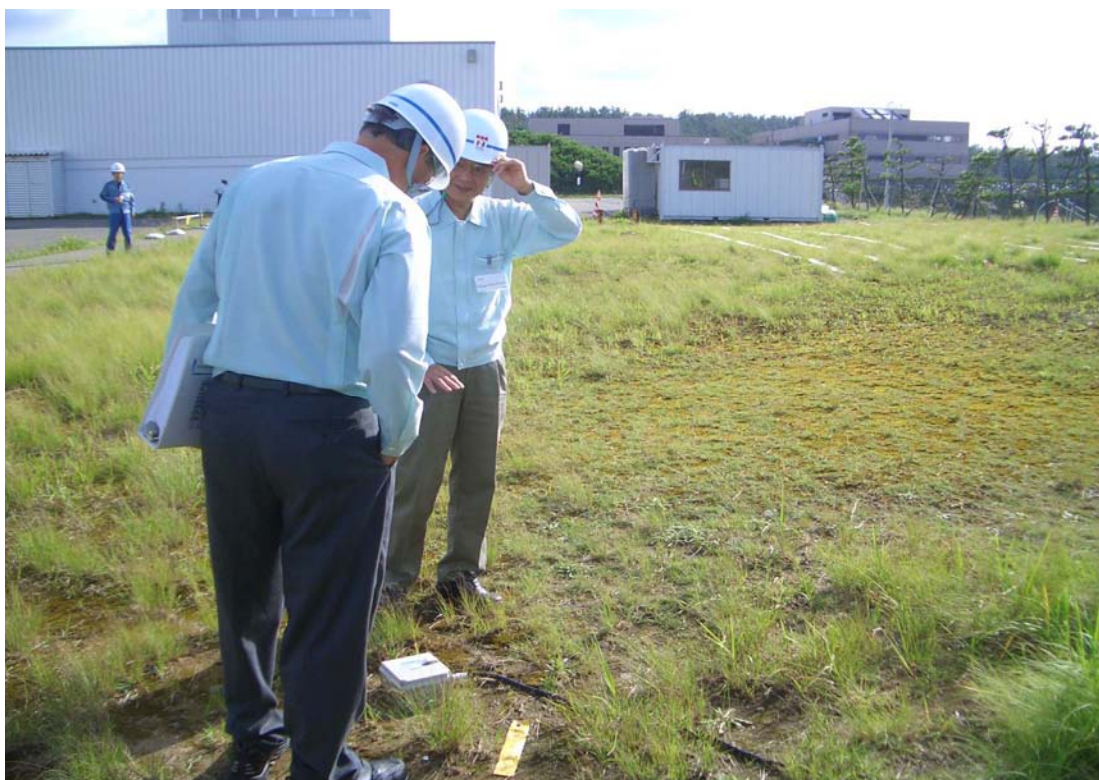
Walkdown Notes/Comments: NVD. No evidence of any earthquake displacement, insulation damage.

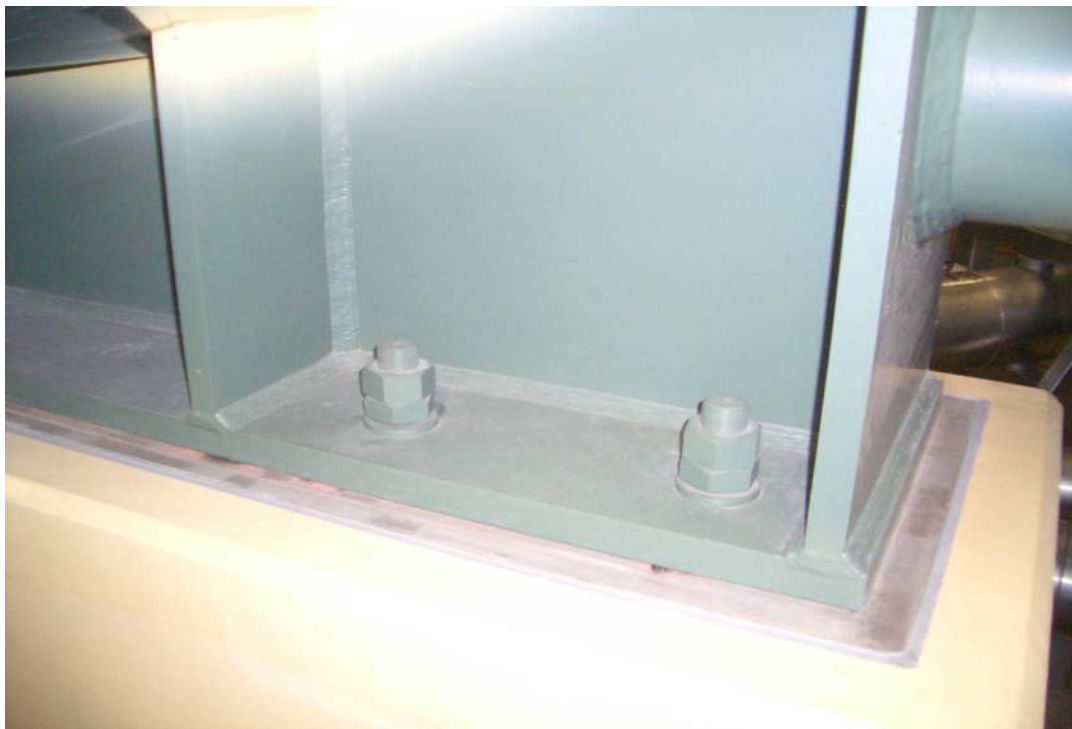
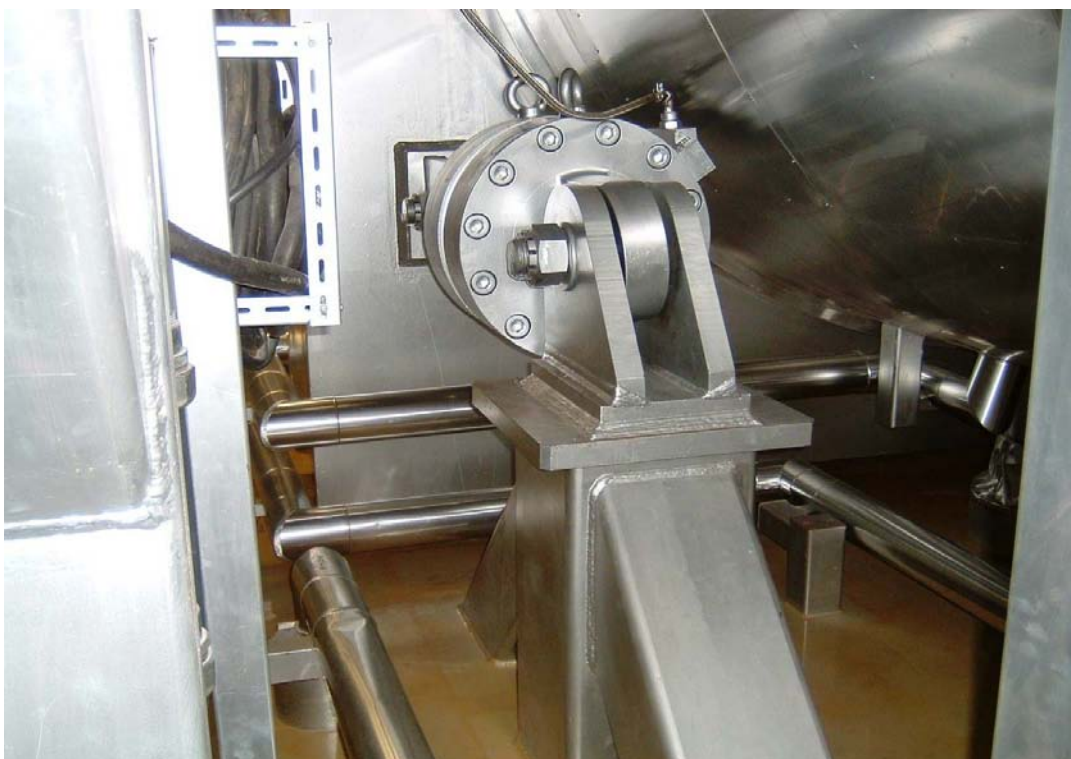
Comments: Evidence of motion, 1/4" at lubricated keyway. Wear marks appear old. NVD

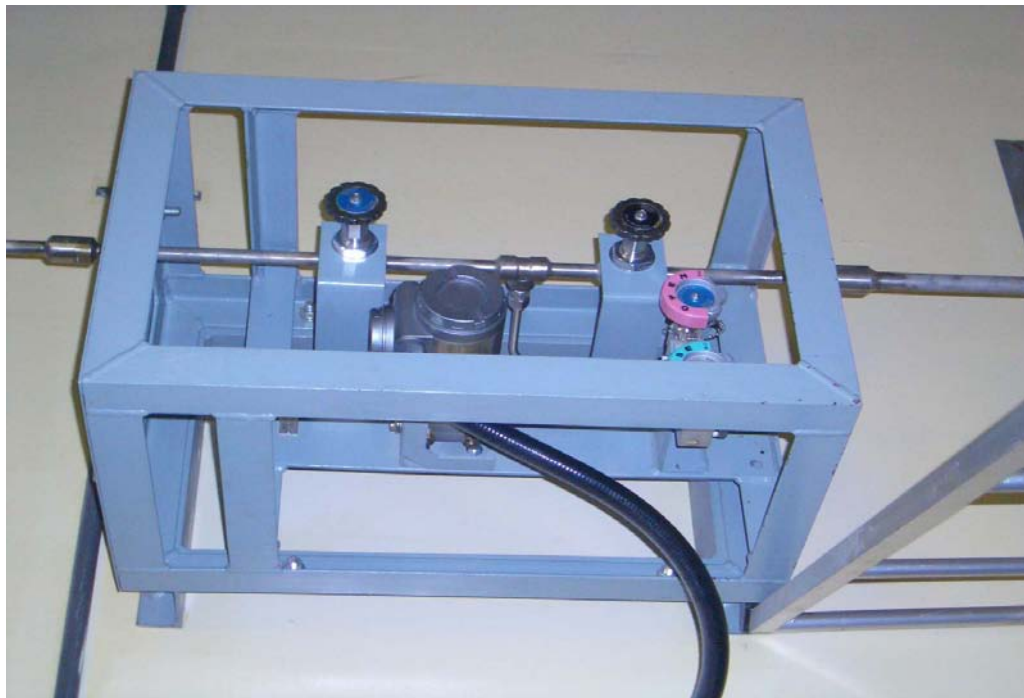
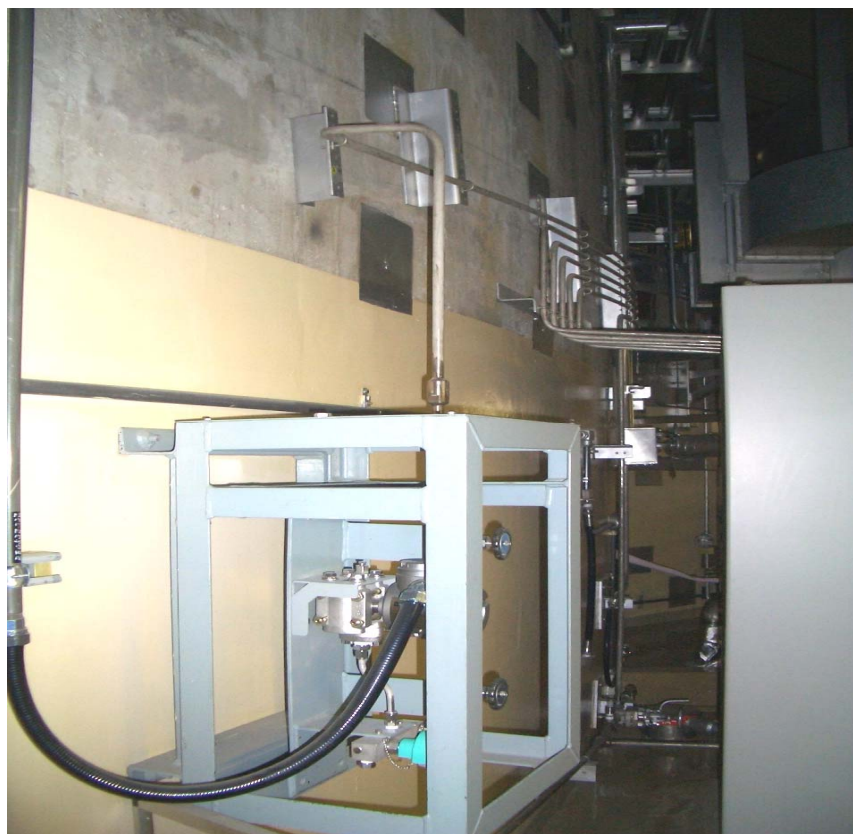
Walkdown Notes/Comments: NVD, Undisturbed condition

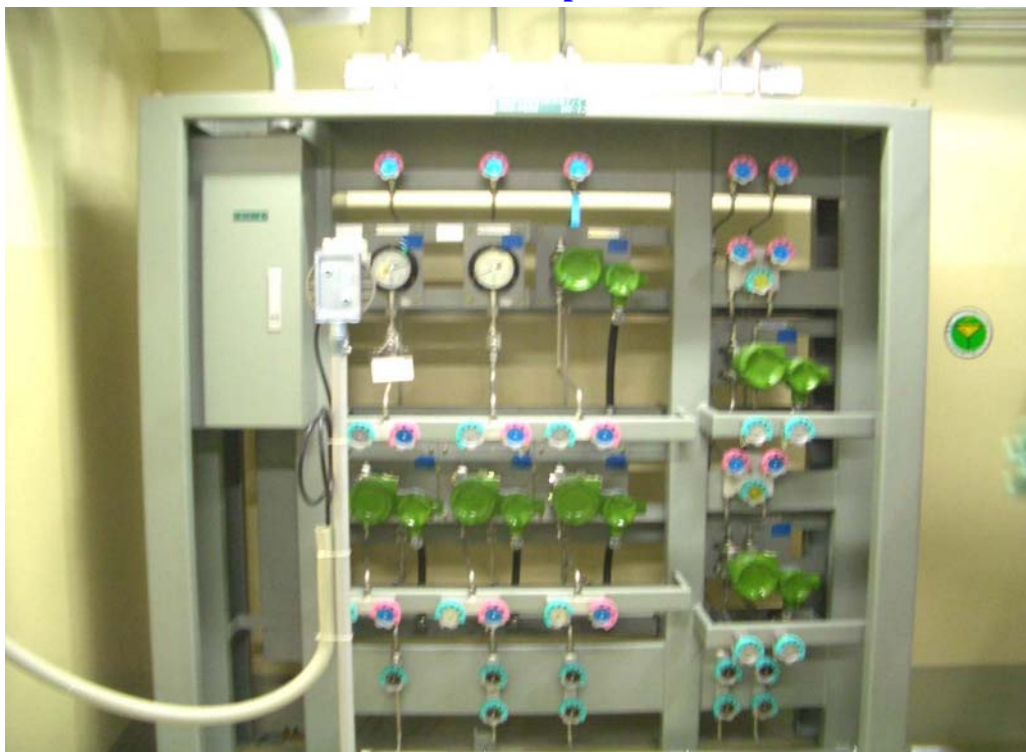
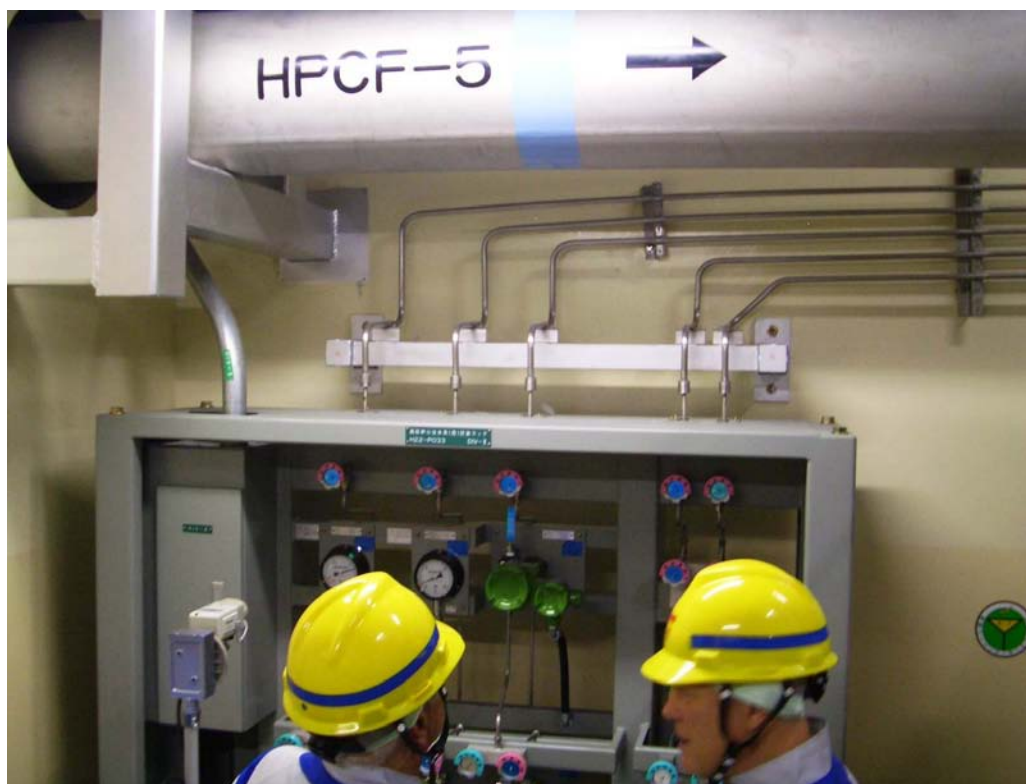
Comments: Ground strap not observed

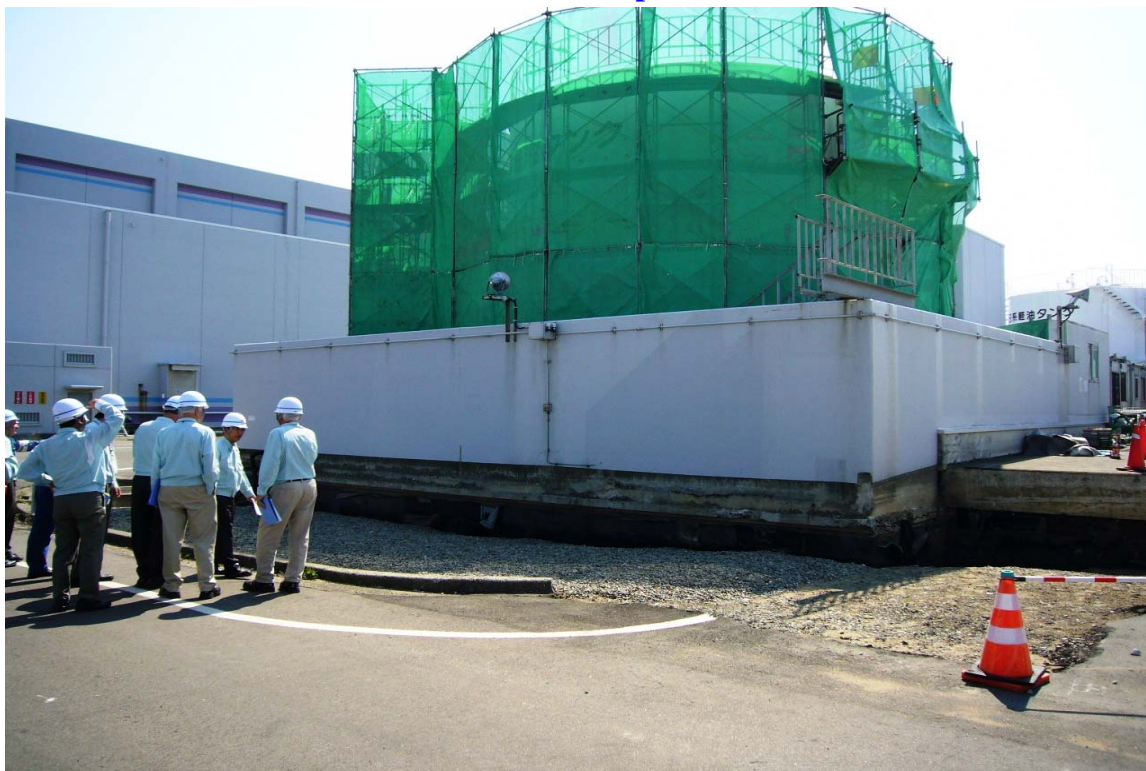
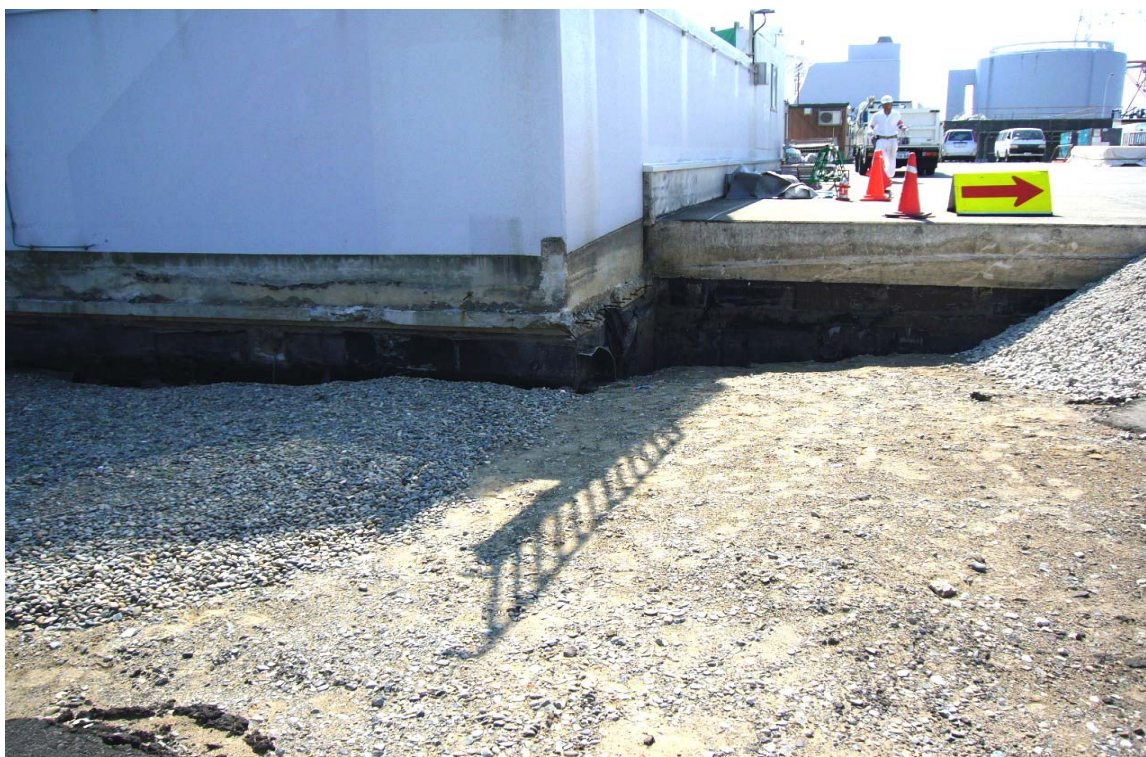
Comments: Significant failures of anchor bolts and pedestals

Comments: Damage apparent

Walkdown Notes/Comments: General failures of several tank anchorages – pulled out anchors, severely cracked pedestals. Caustic tank tipped over partially and was restrained by fire protector piping.

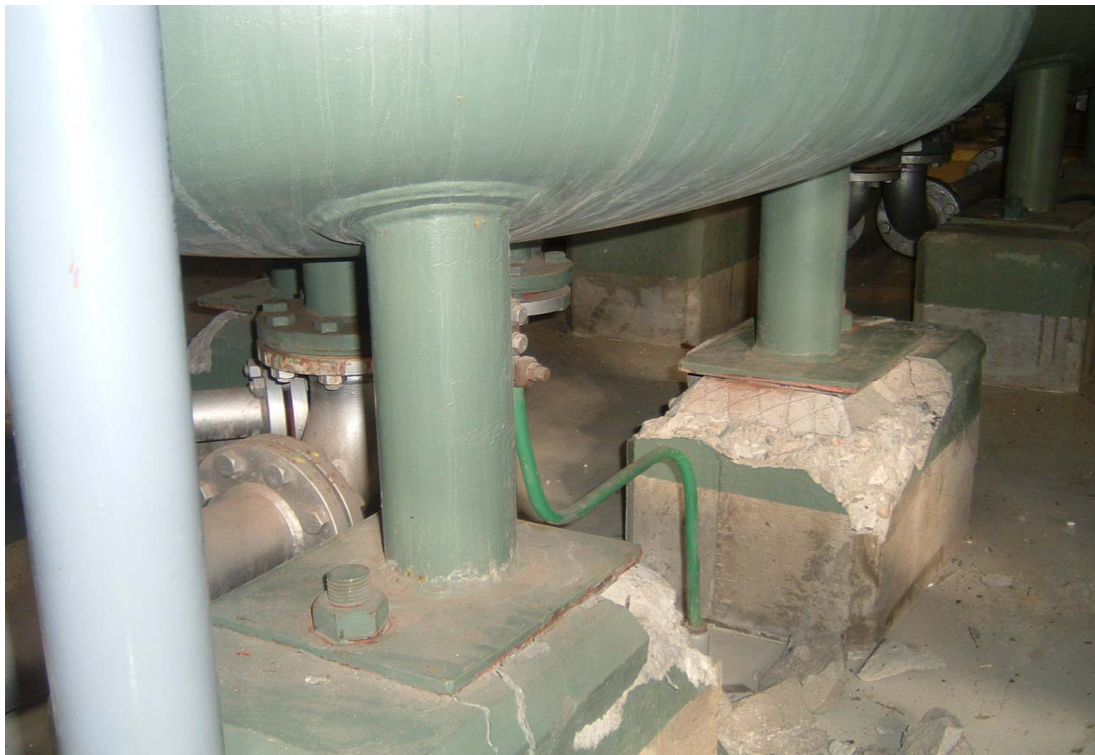
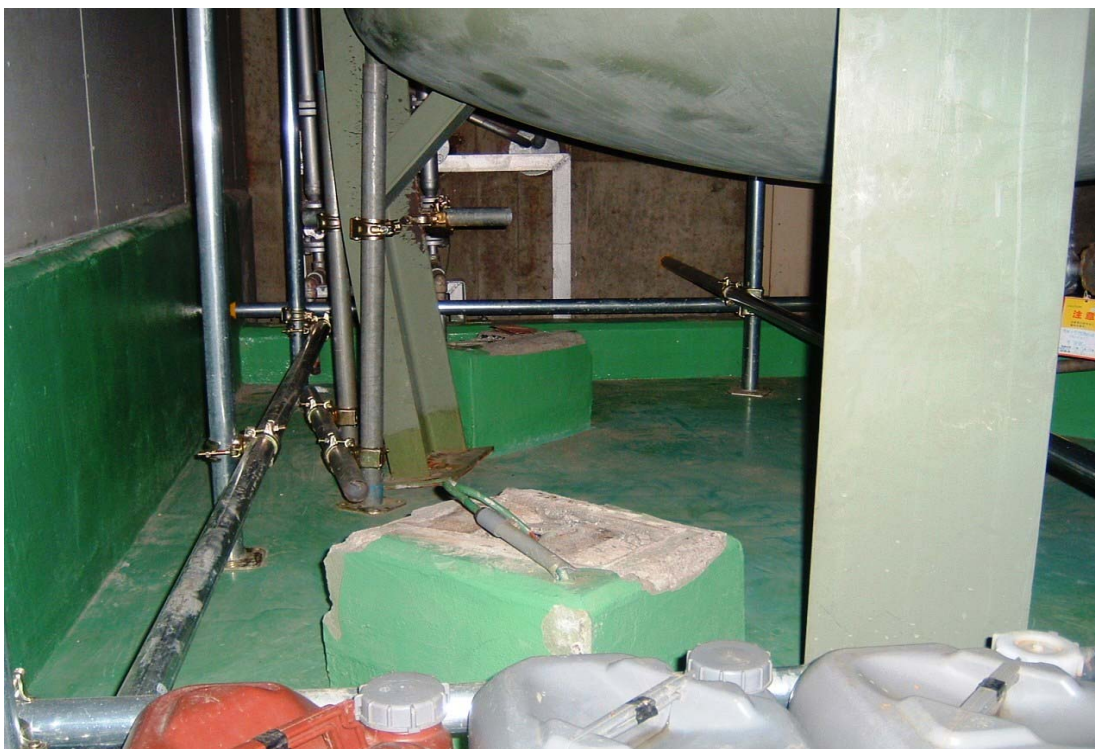
Comments: Multiple failures.

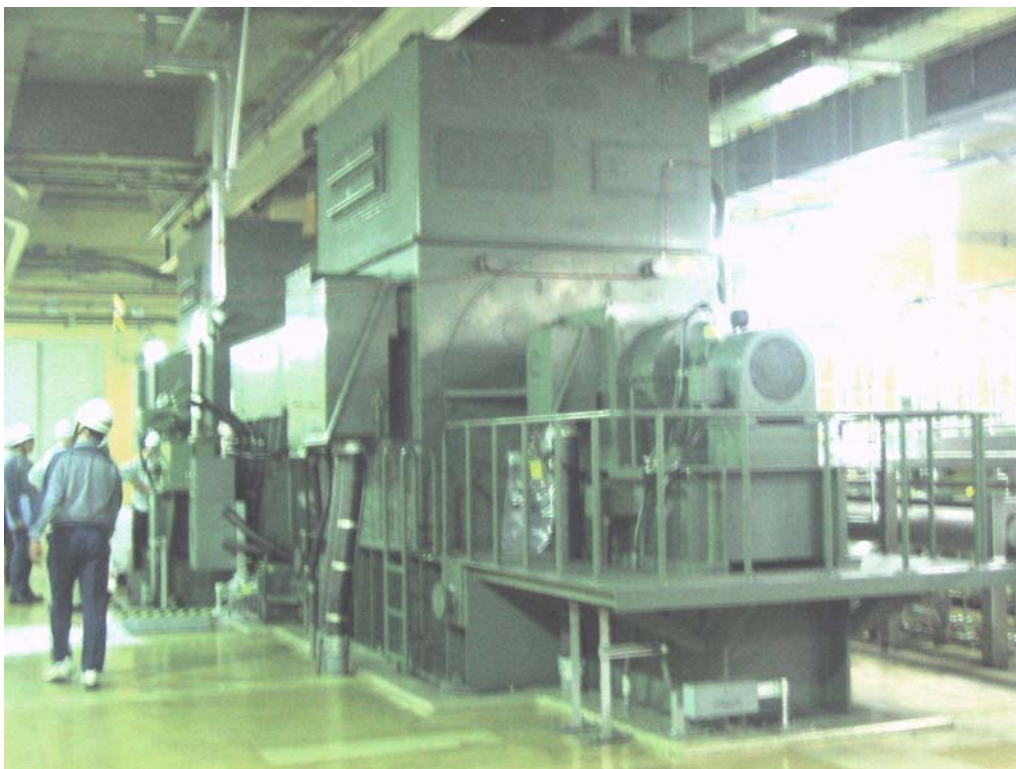
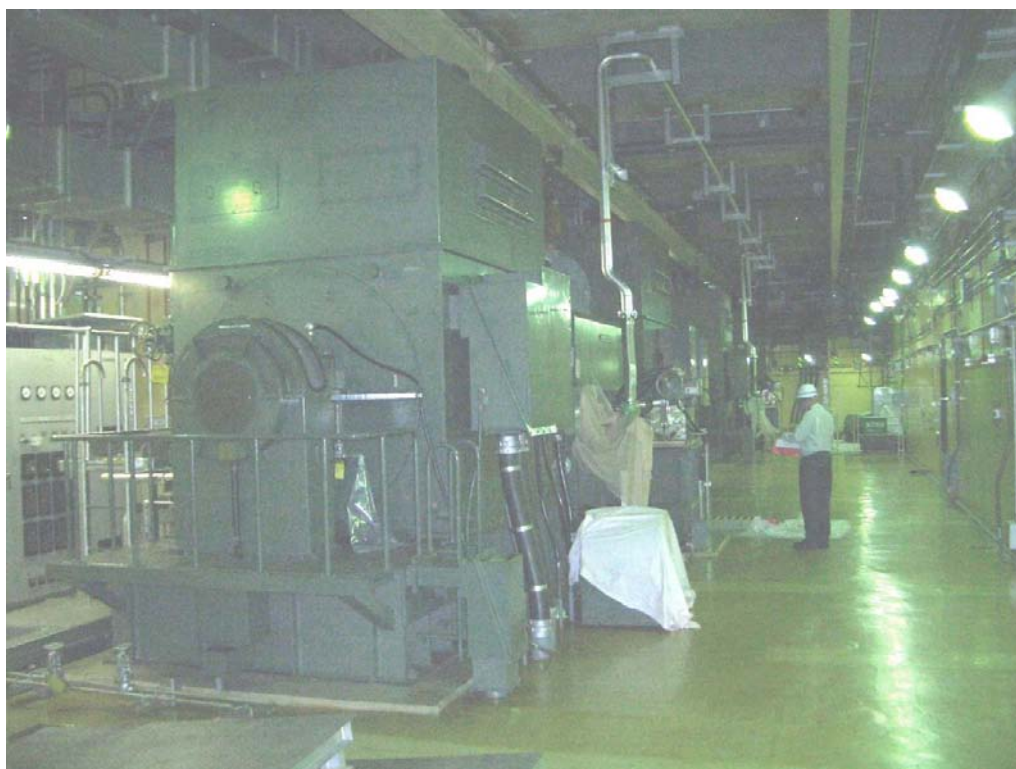
| <i>Comments:</i> No visible damage. | |

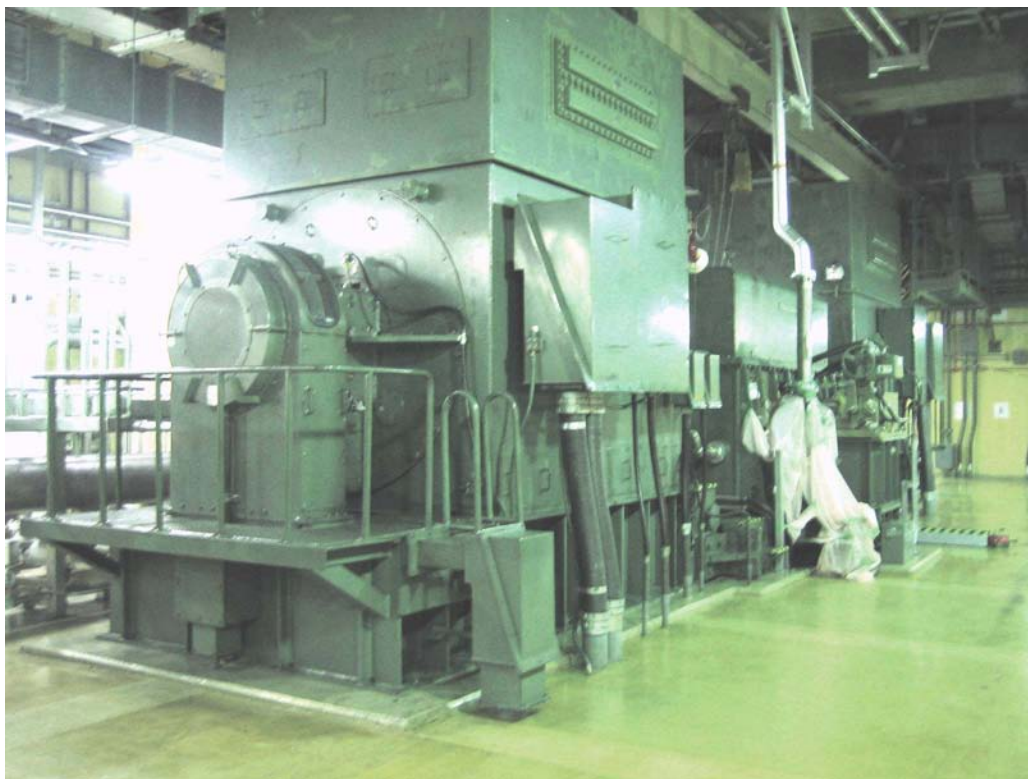
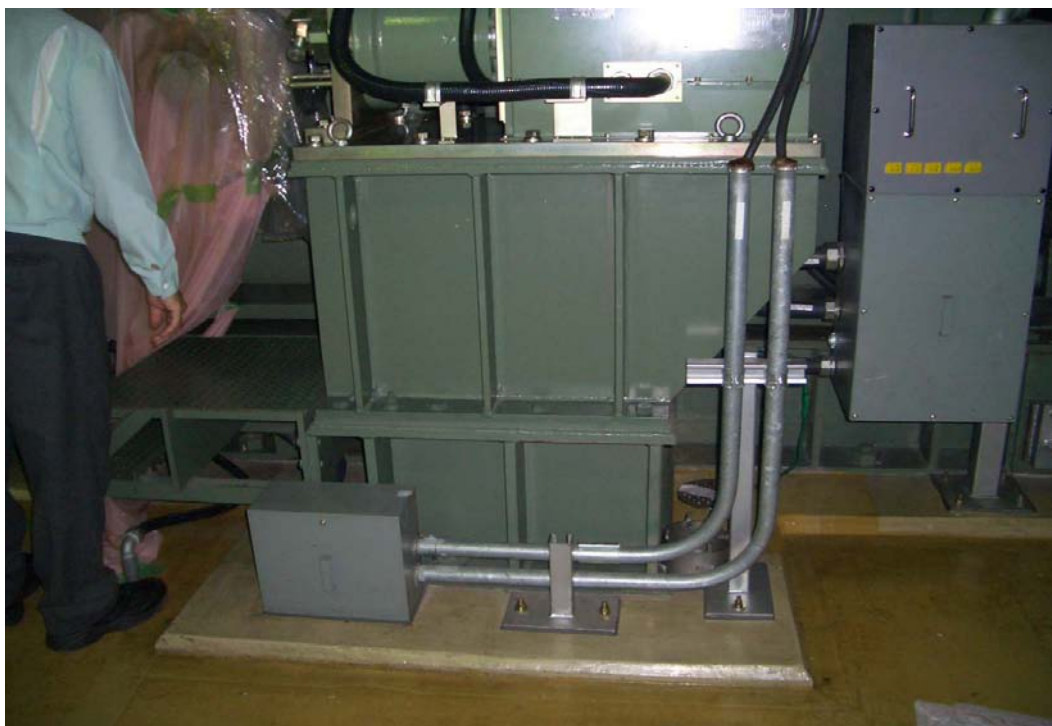
1. Check for snubber damage; e.g., snubbers pulled loose from foundation bolts, evidence of excessive travel, jam up of inertia mechanism/leakage of hydraulic fluid and bent piston rods. **X**
Comments: No snubbers.

2. Check for damage at rigid supports; e.g., deformation of support structure, deformation of pipe due to impact with support structure. **X**
Comments: No evidence of impact adjoining structure components.

3. Check for damage or leakage of pipe at rigid connections; e.g., anchor points with other equipment and structures. **X**
Comments: No visible evidence of damage or leaks.

4. Check for damage or leakage of piping and branch lines. **X**
Comments: No visible evidence of damage or leaks.
5. Check for damage to pipe at building joints and interfaces between buildings. **X**
Comments: Does not cross building joints.

Walkdown Notes/Comments: SLC piping – Stainless Steel; supported by structural steel supports (channels and box sections); attached to supports by U clamps; piping run in very close proximity to structural steel column – no indication of impact between column and piping.

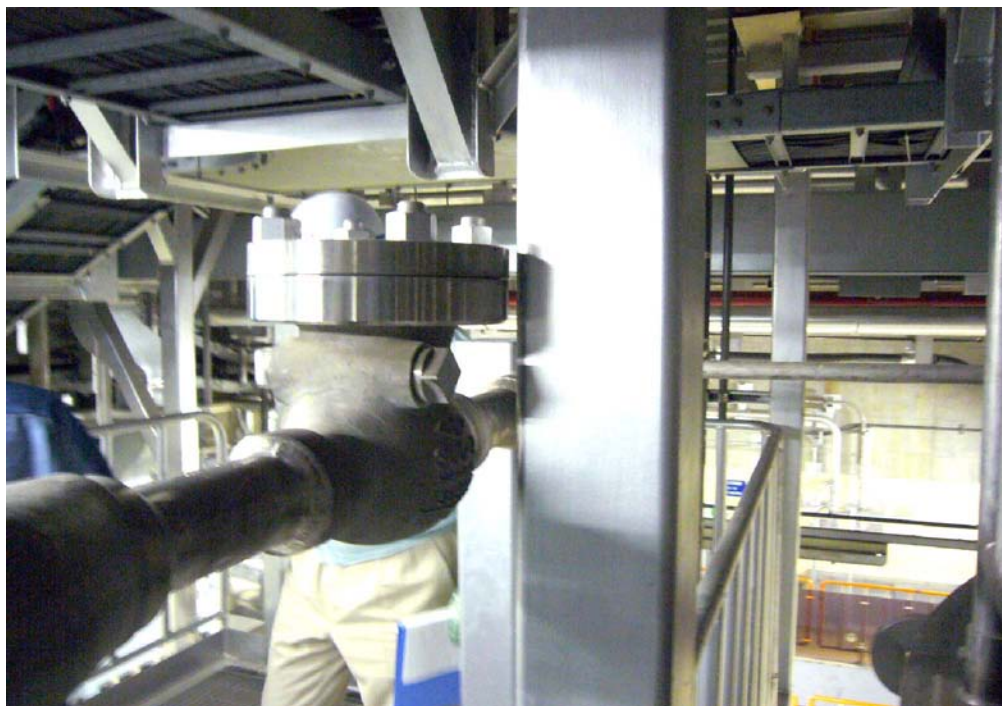
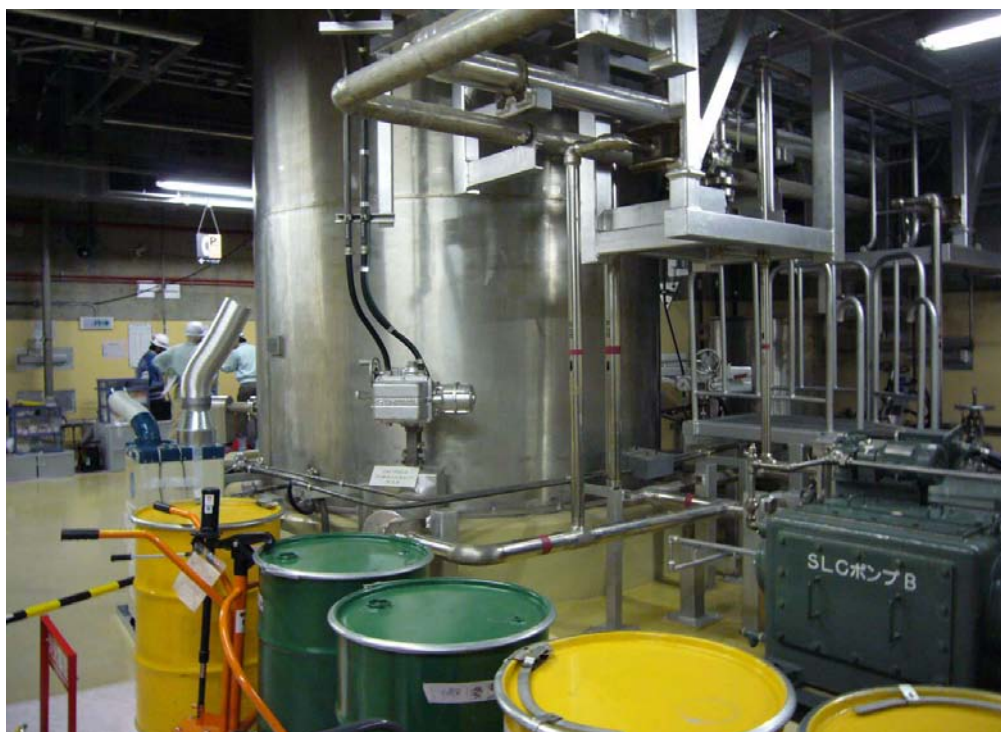
| <i>Comments:</i> No visible damage. | |

Walkdown Notes/Comments: Typical piping configurations and support conditions.

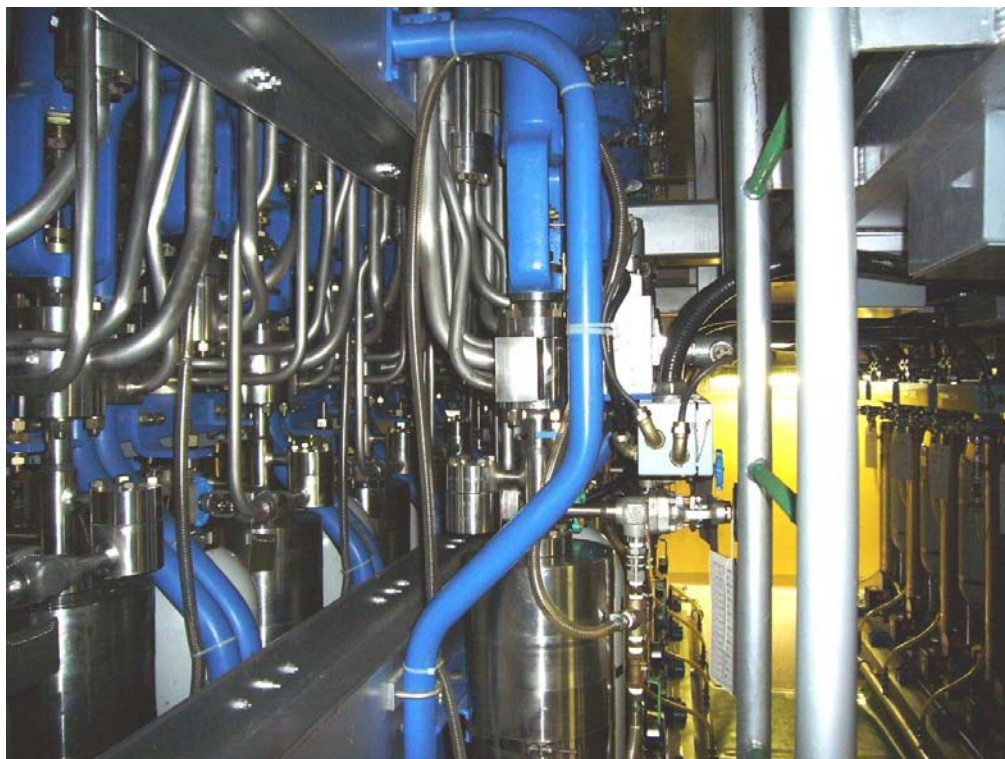
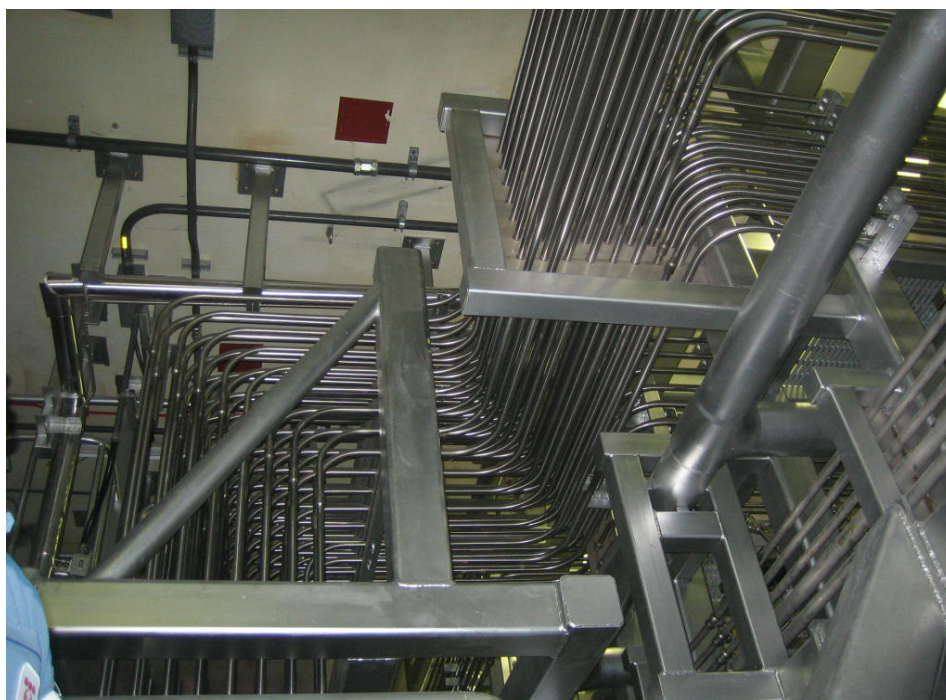
Comments: No leakage observed during the visual inspections

Walkdown Notes/Comments: Unit 7 was operating at the time of the earthquake and shutdown successfully due to the seismic scram. Conclusion is that the CRDs and HCUs operated during the earthquake. October 11, TEPCO announced that one of the 205 control rods for Unit 7 was stuck in the core and could not be removed after removing the fuel assemblies surrounding it. Although this anomaly has been reported, the evidence is that the shutdown of Unit 7 occurred uneventfully. CRD HCUs very well supported (see Photos). No visible damage. Operated successfully during the NCOE

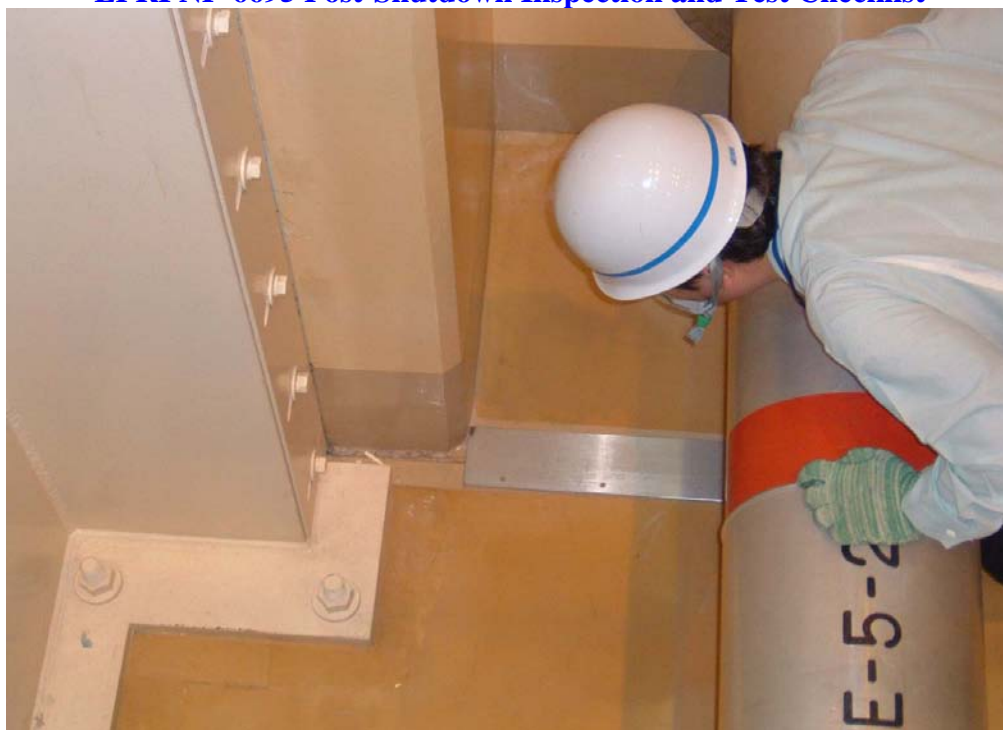
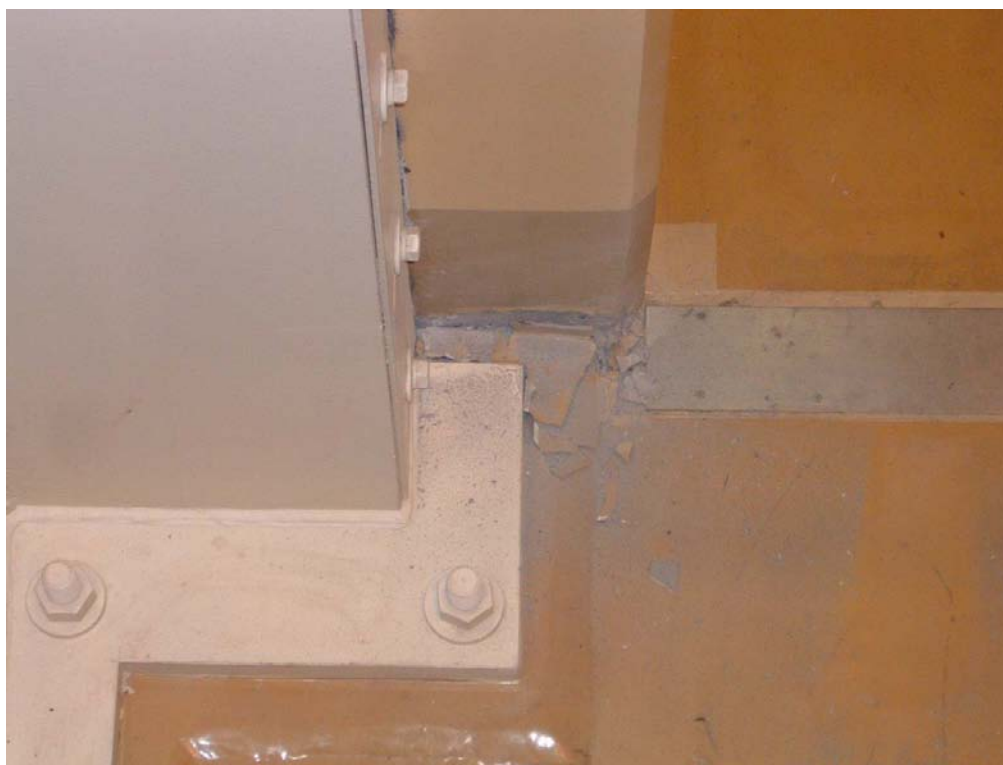
1. Check for damage to attached conduit/tubing and ground straps. **X**
Comments: None. Flexible conduit.
2. Check for damage due to impact or earthquake induced flooding or spraying. **X**
Comments: None. Supported on wall - no sign of impact.
3. Verify sensor operation with readout check at local/control room indicators. ☐
Comments: Not verified – not tested as of 09/26/2007

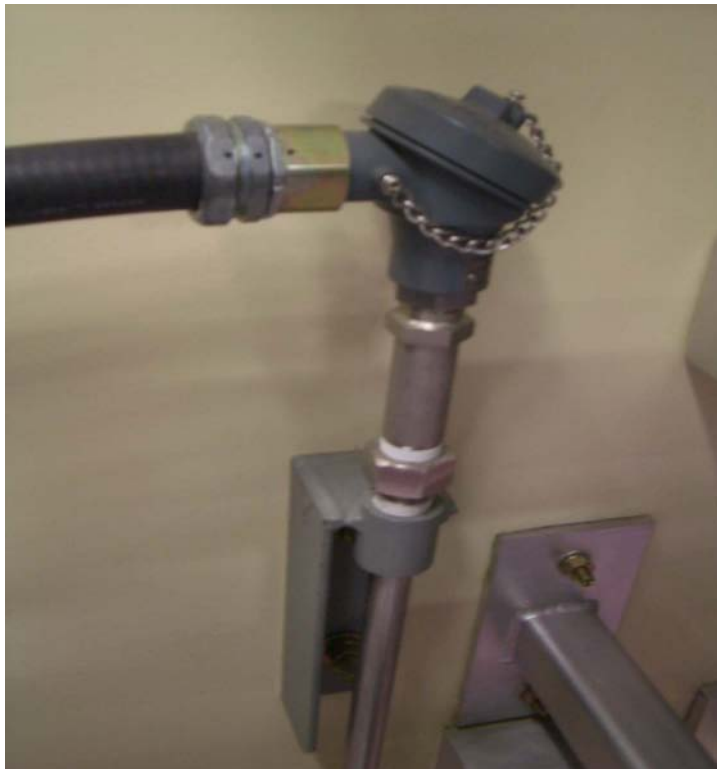
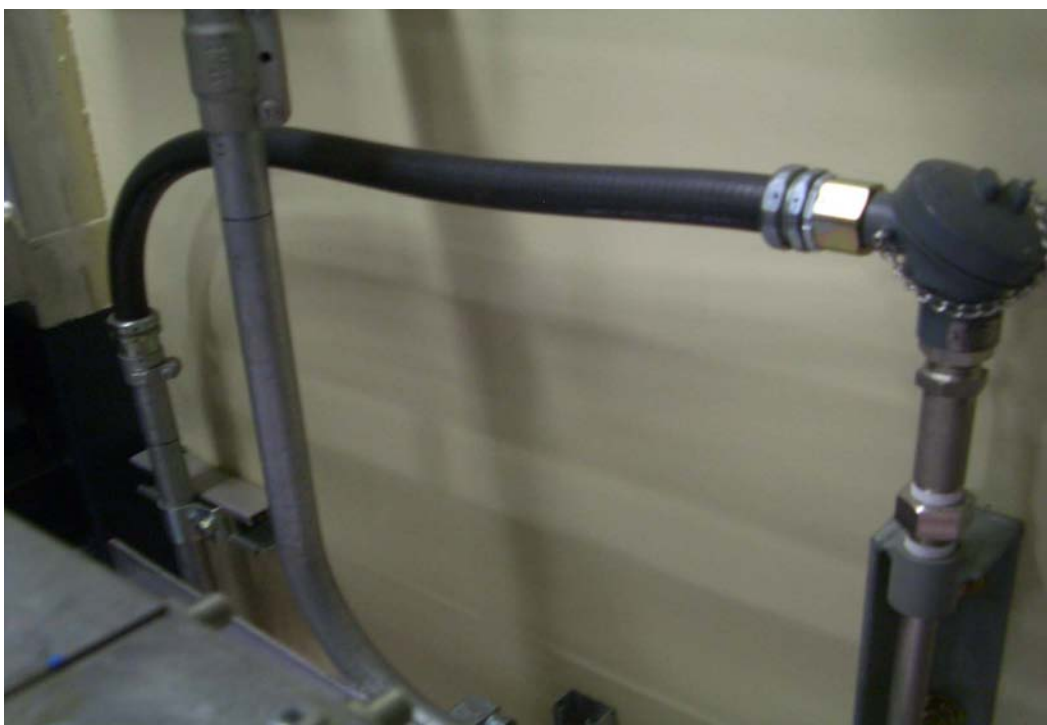
| <i>Comments:</i> No visible damage. | |
