**SUBJECT: MITSUBISHI HEAVY INDUSTRIES – REQUEST FOR WITHHOLDING ROOT CAUSE ANALYSIS AND SUPPLEMENTAL TECHNICAL EVALUATION REPORT INFORMATION FROM PUBLIC DISCLOSURE**

**Root Cause Analysis Report for tube wear  
identified in the Unit 2 and Unit 3 Steam Generators of  
San Onofre Nuclear Generating Station**

On January 31, 2012, after the replacement steam generators (RSGs) supplied by MHI had been operating for approximately 11 months, SONGS Unit 3 was brought into an unplanned shutdown due to primary to secondary leakage of approximately 82 gallons/day in one RSG. The direct cause of the leakage was determined to be tube to tube wear in the free span section of the U-bend region of the RSG, leading to a leak from one of the tubes in that region.

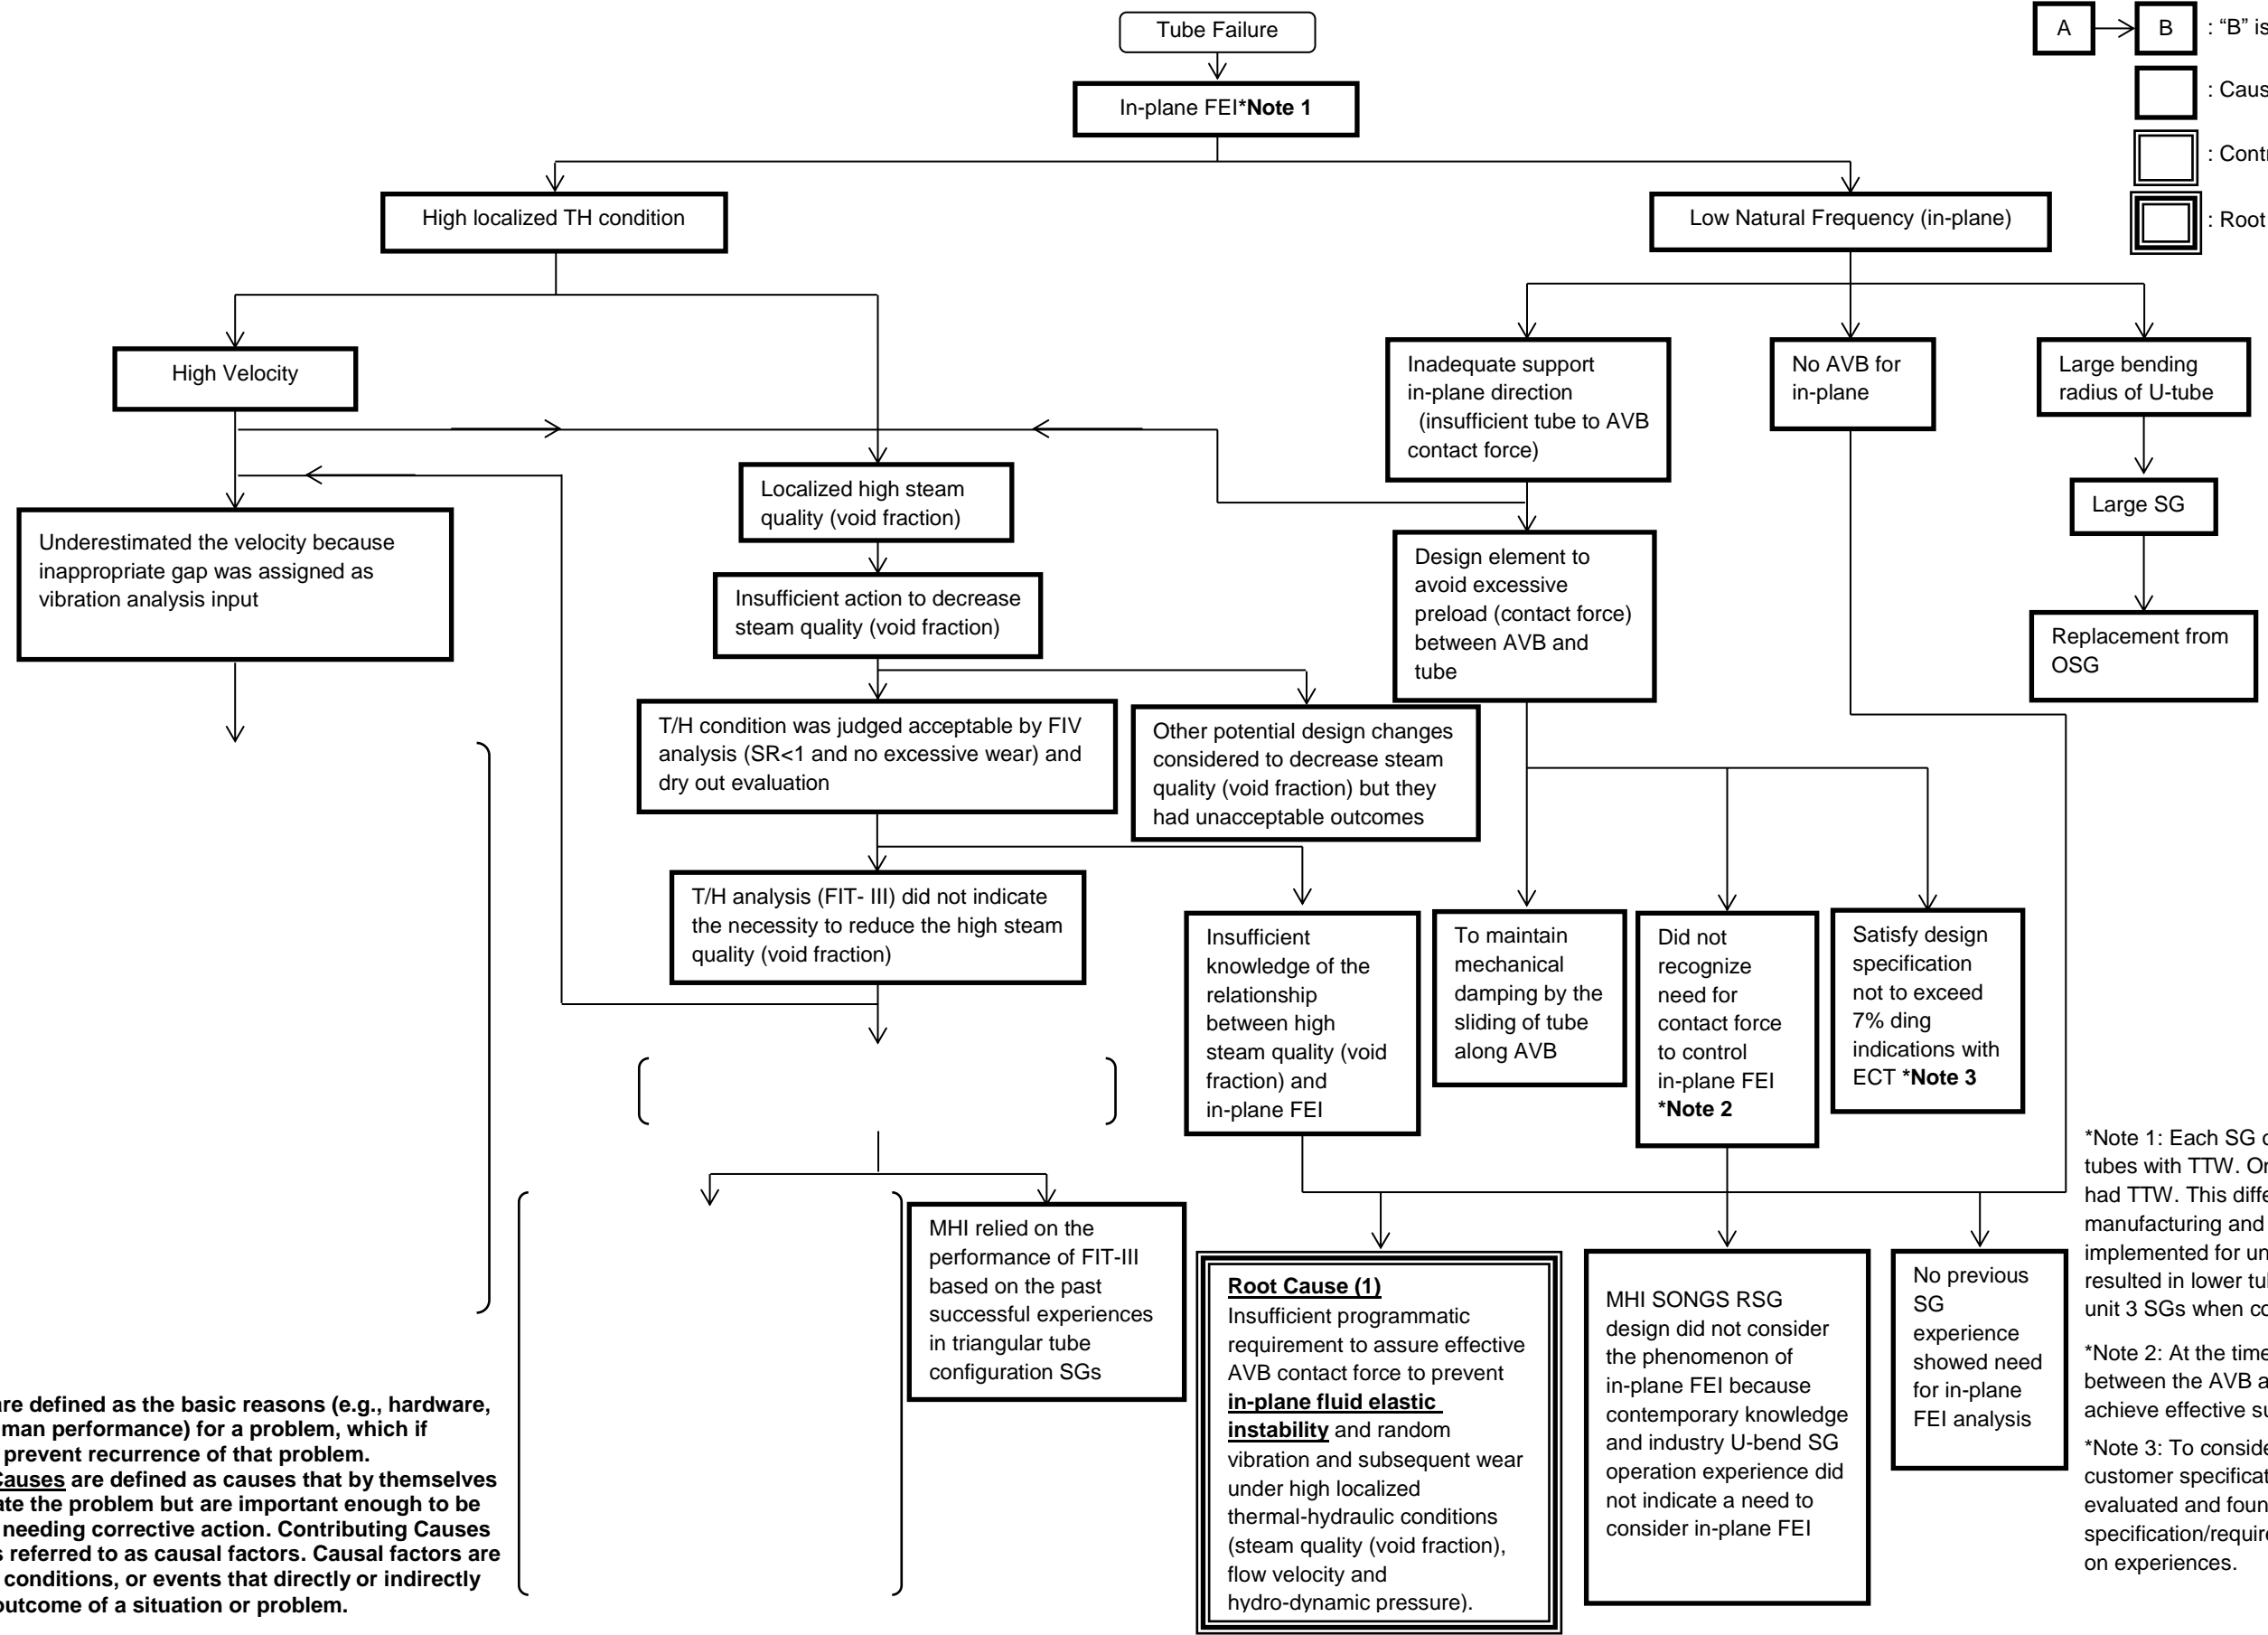
### Cause-effect analysis for the tube to tube wear

\*Note 1: Each SG on unit 3 had about 160 tubes with TTW. Only 2 tubes in one unit 2 SG had TTW. This difference was caused by manufacturing and fabrication improvements implemented for unit 3. These improvements resulted in lower tube to AVB contact force in unit 3 SGs when compared to unit 2 SGs.  
 \*Note 2: At the time of design a narrow gap between the AVB and tube was believed to achieve effective support condition.  
 \*Note 3: To consider identifying specific customer specification but also note that MHI evaluated and found such specification/requirement acceptable based on experiences.

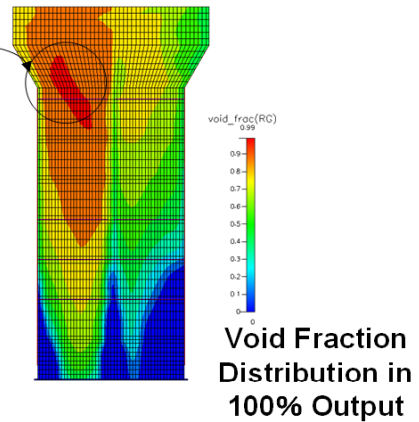
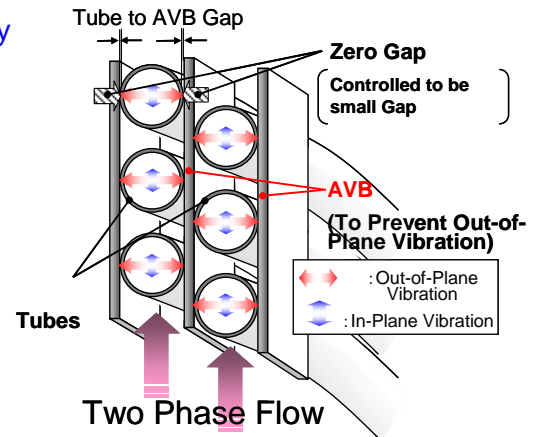
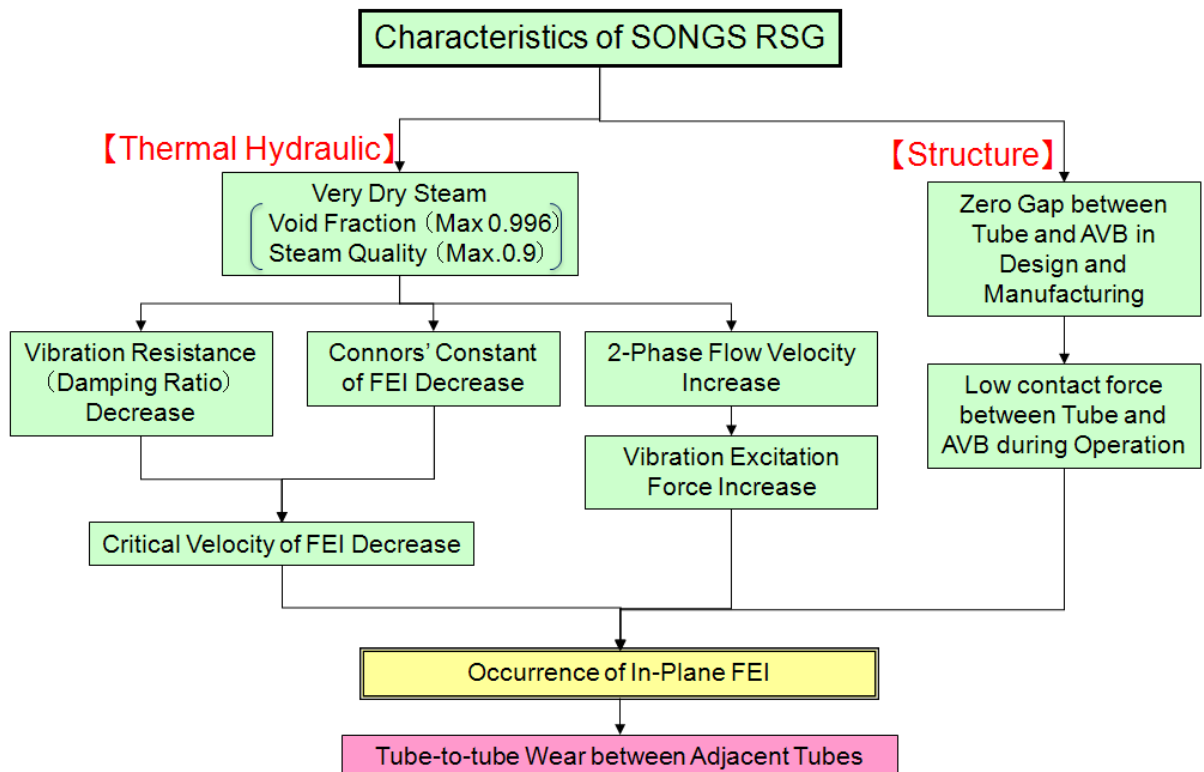
Fig. 2.2-1 Type 1 Wear (TTW) In-Plane Mechanism

As discussed in Sections 5 and 6.1 of the TER, in order for large in-plane displacements to occur two conditions are necessary. First, the tube needs to be unrestrained in the in-plane direction and second the environment must be conducive to FEI (velocity, density, damping, etc.). These causes are summarized in Fig.2.2-1. This figure shows the same mechanism as Fig.6.1-1 in the TER (Ref. 1).

- ✓ Tube between 2 flat AVBs
  - AVB Design Assumes Out-of Plane Vibration  
Since out-of-plane FEI is more likely to happen compared to in-plane FEI, AVBs are placed at the sides of tube to prevent out-of-plane vibration
- ✓ 6 V-Shaped AVBs (12 support points)
  - Number of AVB Support Points are confirmed to satisfy ASME FEI Requirements
- ✓ Designed and fabricated for effective "Zero" Gap between Tube and AVB in hot condition

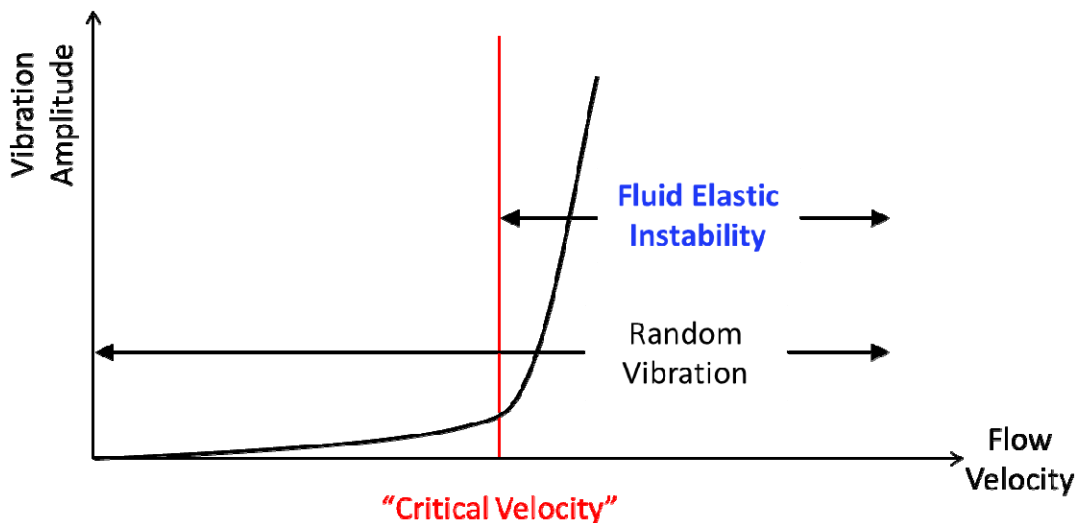
Figure 2.3-1 Relation between Vibration Amplitude and Flow Velocity

In a tube array, a momentary displacement of one tube from its equilibrium position will alter the flow field and change the force balance on the neighboring tubes, causing them to change their positions in a coordinated manner. When the energy extracted from the flow by the tubes exceeds the energy dissipated by damping it produces fluid elastic vibration. The threshold for this instability is shown in Figure 2.3-1 below, where one axis (Y) of the graph is vibration amplitude and the other (X) is flow velocity. The curve shows that as flow velocity increases, vibration initially increases gradually. As velocity continues to increase, it will reach a point where the slope of the vibration line changes abruptly. The point on the curve where the slope changes is termed the "critical velocity".

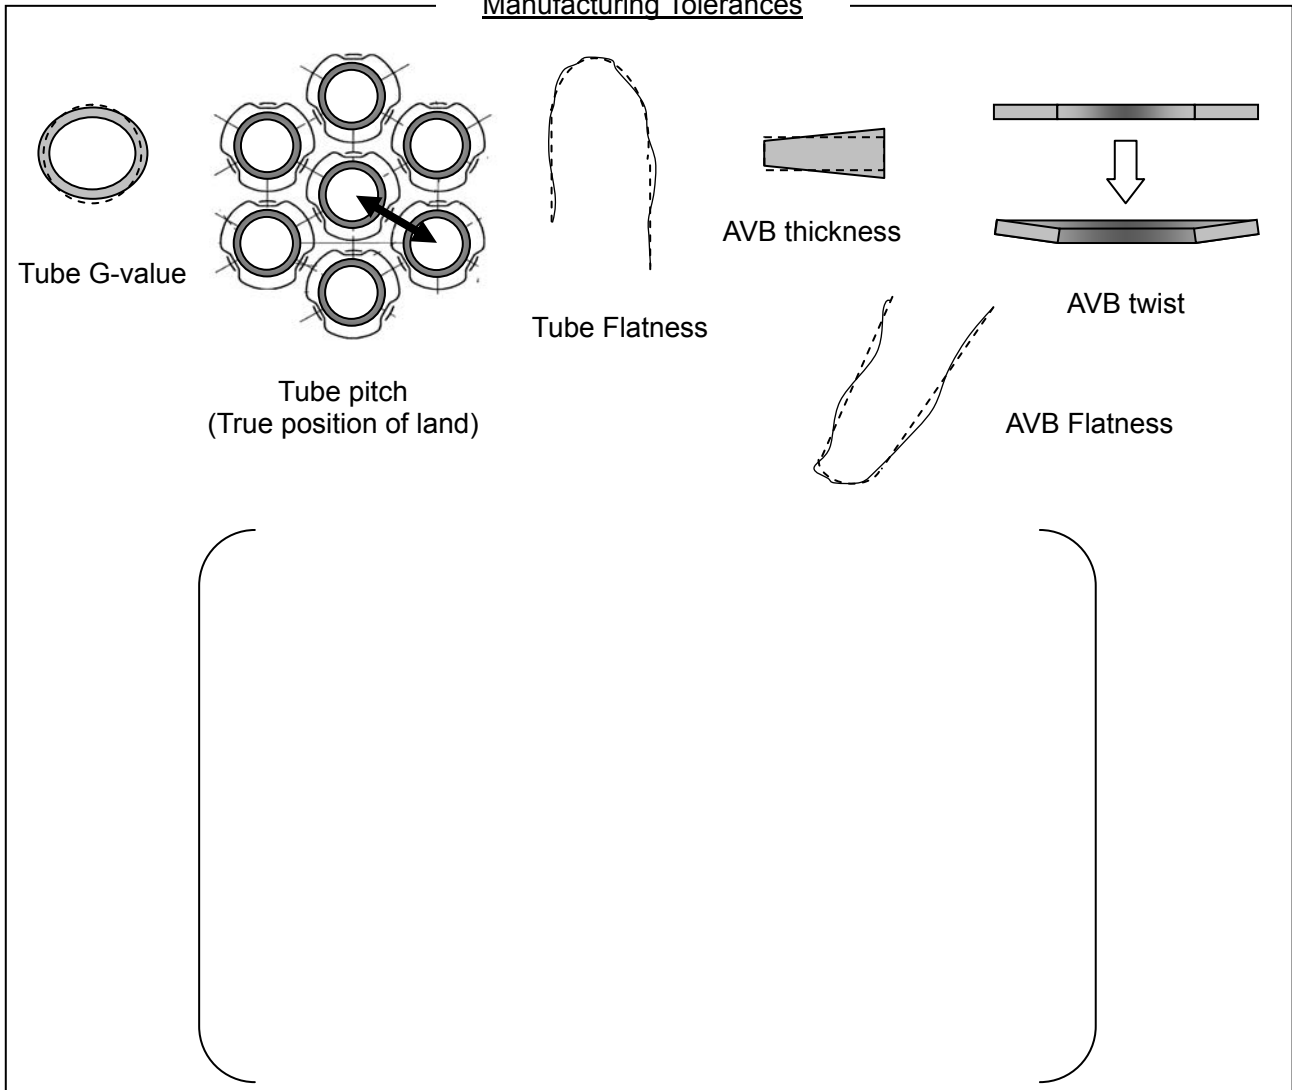
Fig.2.3.3-3 Contact Force Simulation with Manufacturing Tolerances

A comparison of Fig. 2.3.4-3 showing the average void fraction and the figures on the bottom of Fig. 2.3.3-3 showing Unit 2 and Unit 3 contact forces indicates that the tubes in the area of average high void fraction also generally have low contact forces, which generally correspond as well to the Type 2 wear maps in Figs. 3.1-1 and 3.1-2. The turbulence induced (random) tube vibration associated with the small gaps and small contact forces combined with the lower tube damping in the high void fraction regions is sufficient to produce the observed wear.

According to the manufacturing dimensional tolerance analysis, the average contact force in the Unit 3 SGs was found to be smaller than the average contact force in the Unit 2 SGs, as shown in Fig. 2.3.3-3. Therefore, it is concluded that the contact forces of Unit 3 were more likely to be insufficient to prevent turbulence induced (random) vibration of tubes and the Unit 3 SGs were more susceptible to turbulence induced (random) vibration, as shown in Figs. 3.2.1-4 and 3.2.1-5.

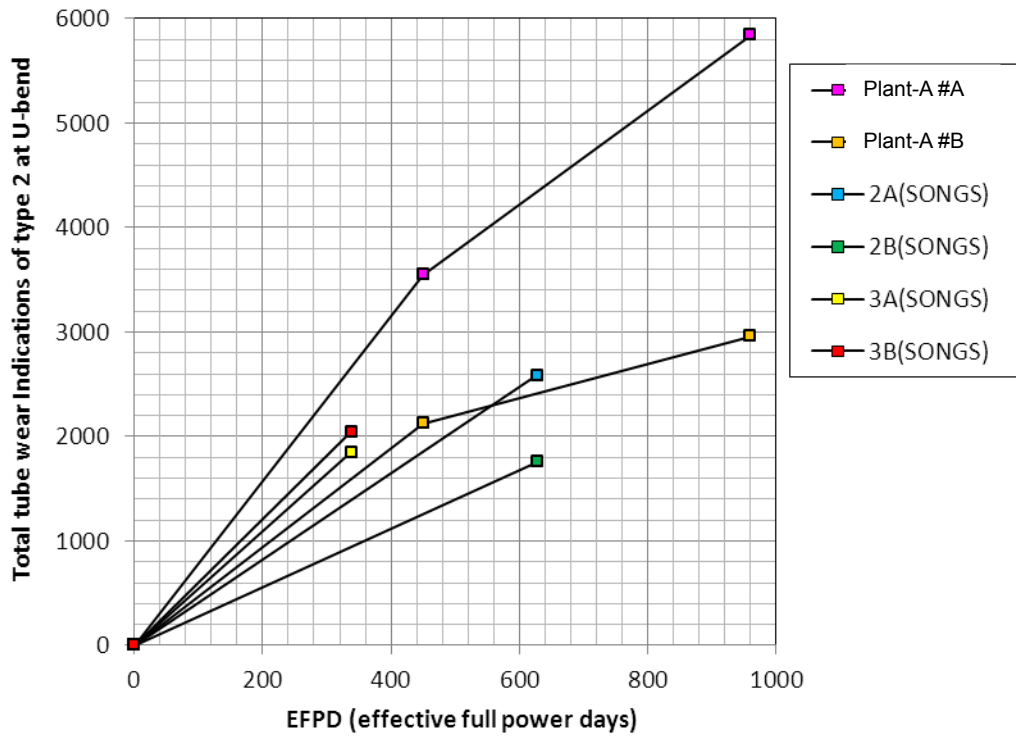
Fig.3.2.1-4 Total Tube-to-AVB Wear Indications

Figure 3.2.1-4 compares the total number of tube-to-AVB wear indications for Plant-A, SONGS Unit 2, and SONGS Unit 3 as a function of time and Figure 3.2.1-5 shows the average wear depths for the three plants (six RSGs) as a function of time. As can be seen from these figures, the total number of indications and average wear depth at Plant-A are comparable to that at SONGS.

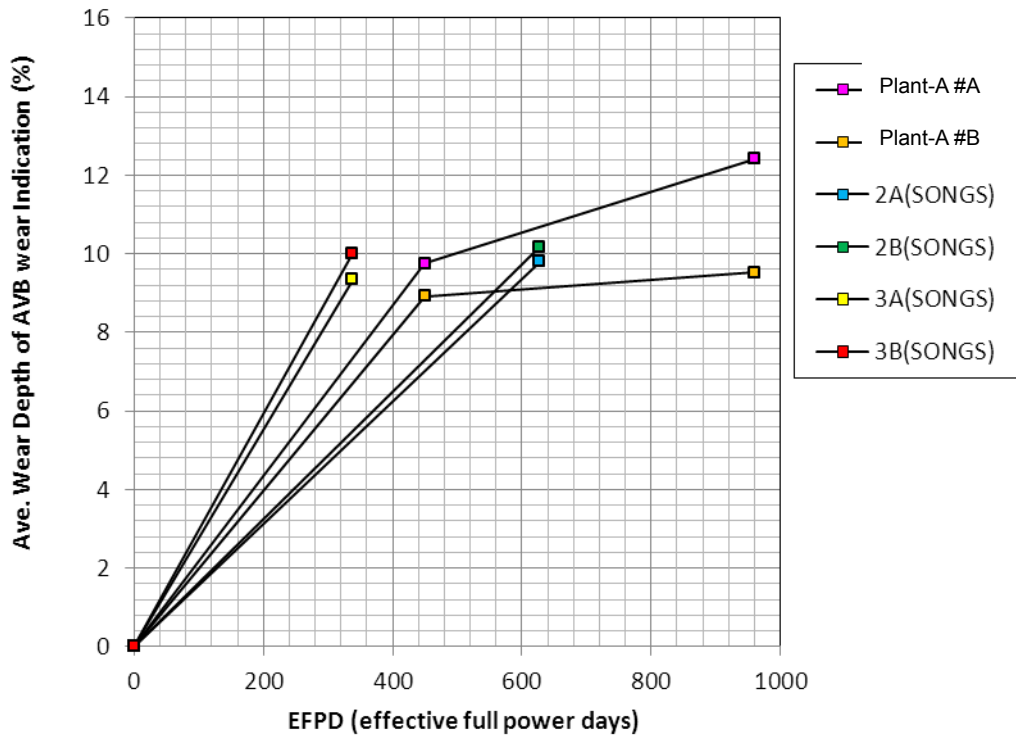
Fig.3.2.1-5 Average Tube-to-AVB Wear Rate

Figure 3.2.1-5 suggests that the tube-to-AVB wear depths at Plant-A have reached a plateau. The reason for such a plateau is unclear. It may be indicative of the type of tube vibration mechanism or an effect of the support condition. But it is clear that the number of tubes with tube-to-AVB wear at Plant-A is growing (refer to Fig. 3.2.1-2 and 3.2.1-3).

While the number of tubes with Type 2 wear is very similar for Unit 2 and Unit 3 (Compare Table 1-1 and Table 1-2), Unit 2 has operated approximately twice as long as Unit 3. As a result, as shown in Fig. 3.2.1-5, the wear rate in Unit 3 is faster than that for Unit 2. An explanation for this difference is found in the manufacturing assessment which concluded that the tube to AVB contact forces in Unit 3 were less than half than those in Unit 2. (See Section 2.3.3 above.)

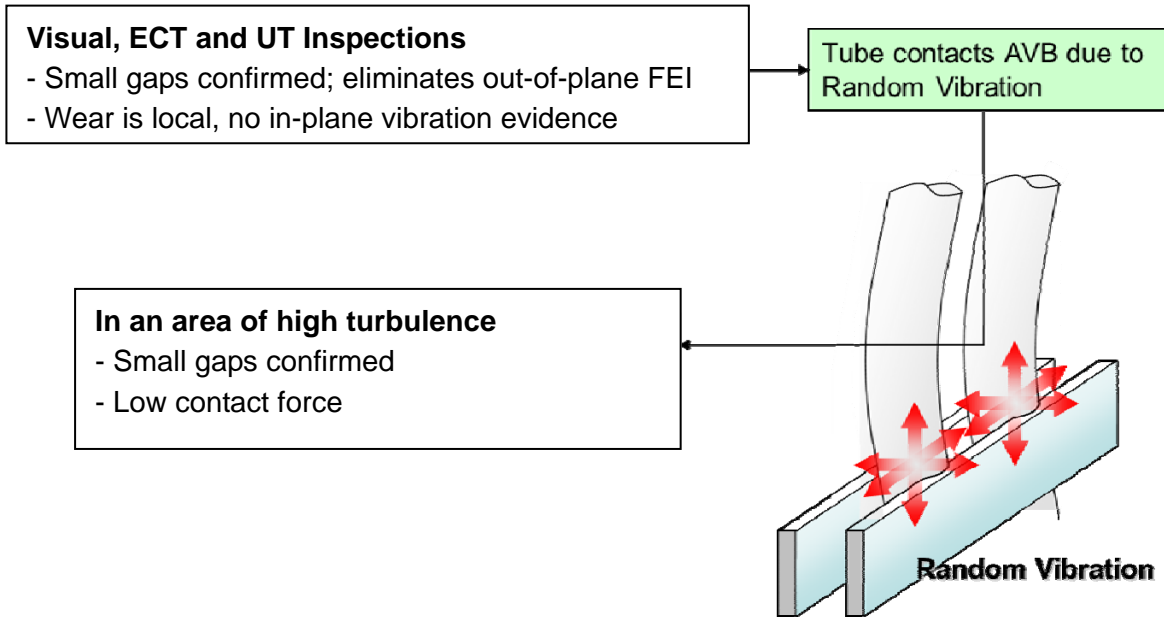
Fig.3.3-1 Type 2 Wear (AVB wear) Mechanism

Fig. 3.3-1 (this figure is similar to Fig. 6.2-1 in the TER (Ref. 1)) provides a summary of the basis for establishing the cause of the Type-2 (tube-to-AVB) wear. Extensive inspections, including visual, eddy current, and ultrasonic methods, indicate that the tube-to-AVB gaps are small at each of the wear sites. This indicates that there are small clearances. Such conditions are sufficient to prevent out-of-plane FEI but not sufficient to prevent turbulence induced (random) vibration and wear.

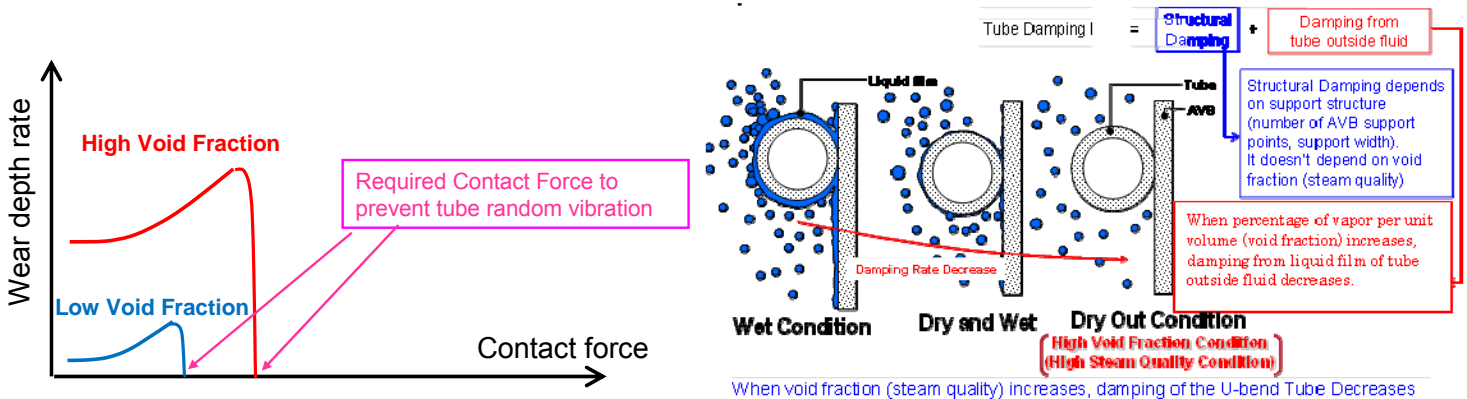
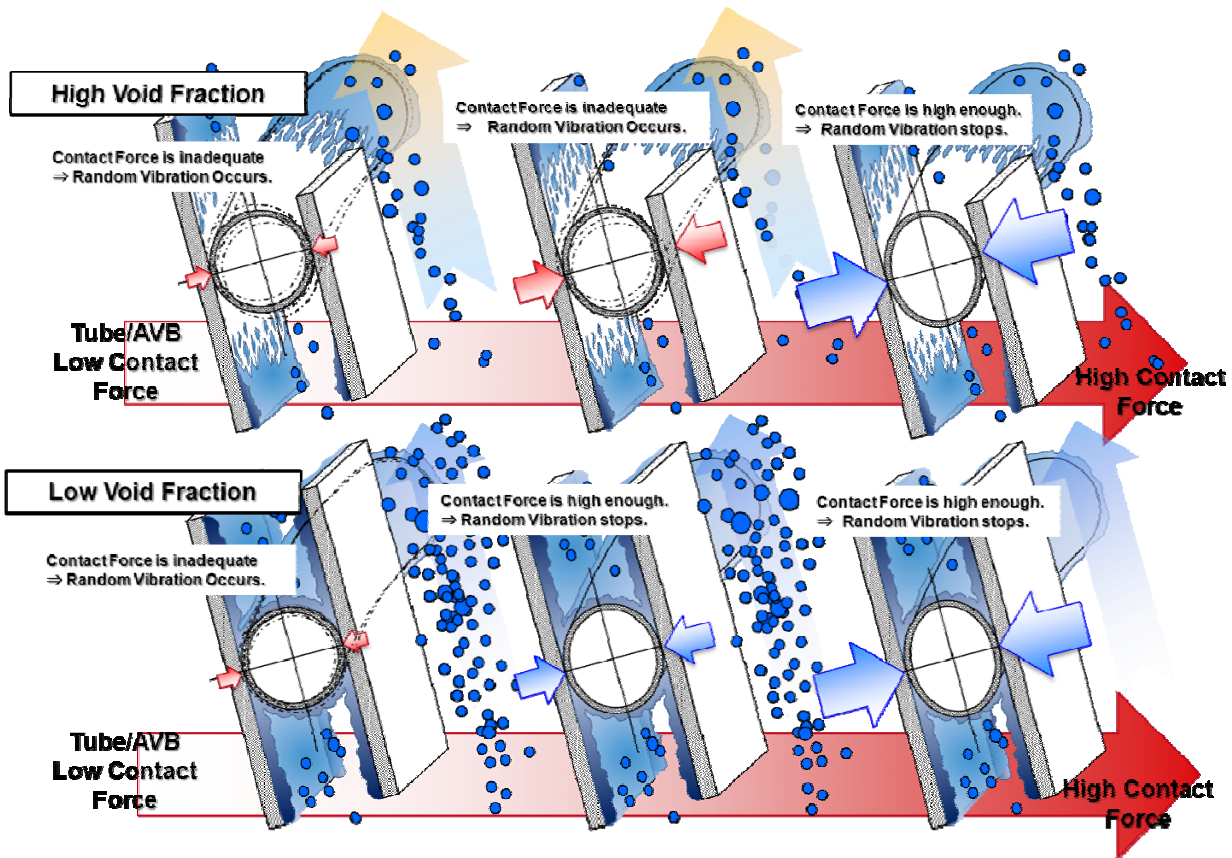
Fig.3.3-2 Contact force sufficient to prevent random tube vibration

As shown in the figure at the upper left corner of Fig.3.3-2, insufficient contact force has an adverse effect on tube wear caused by random tube vibration up to the point where the contact force is sufficient to prevent tube lift-off from (or sliding along) the AVB. The amount of contact force necessary to prevent random vibration is a function of the thermal-hydraulic condition. As the void fraction (steam quality) increases, the amount of contact force necessary to prevent random vibration increases. This is because the higher void fraction (steam quality) results in lower external fluid damping and a reduction in the liquid film damping (squeeze film damping).

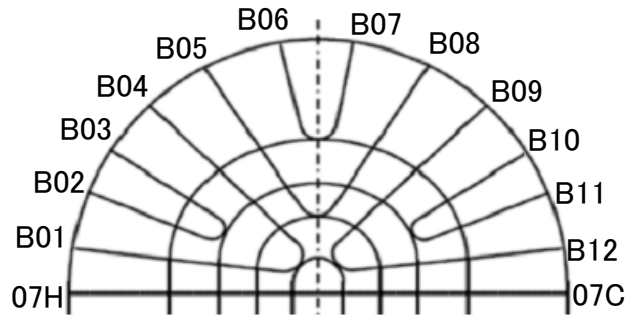
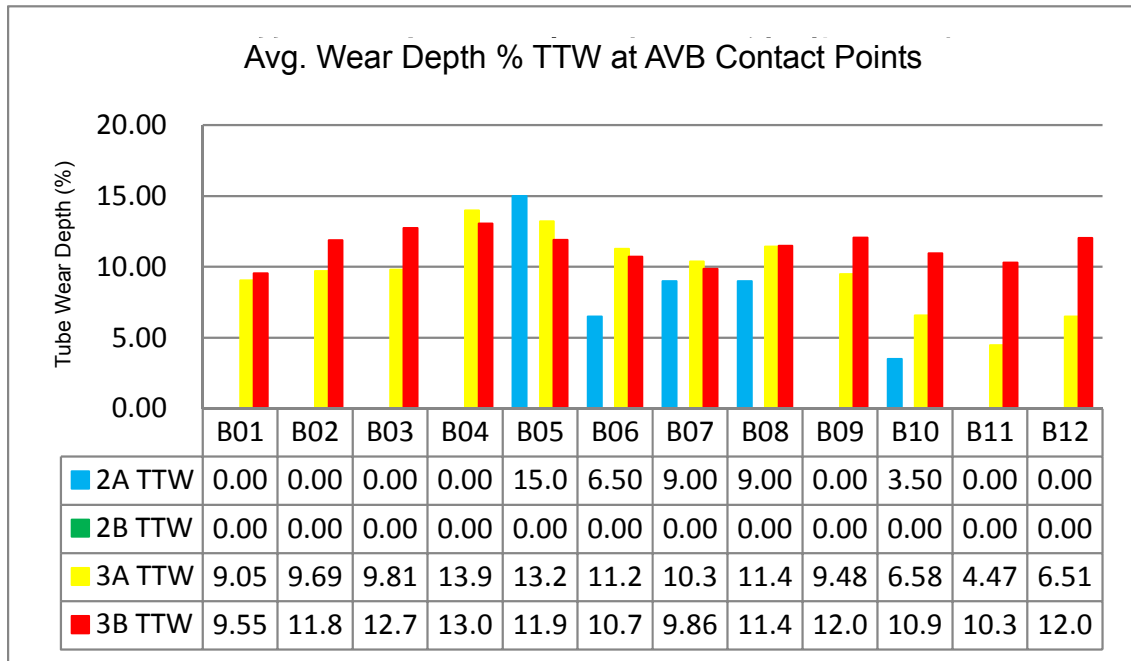
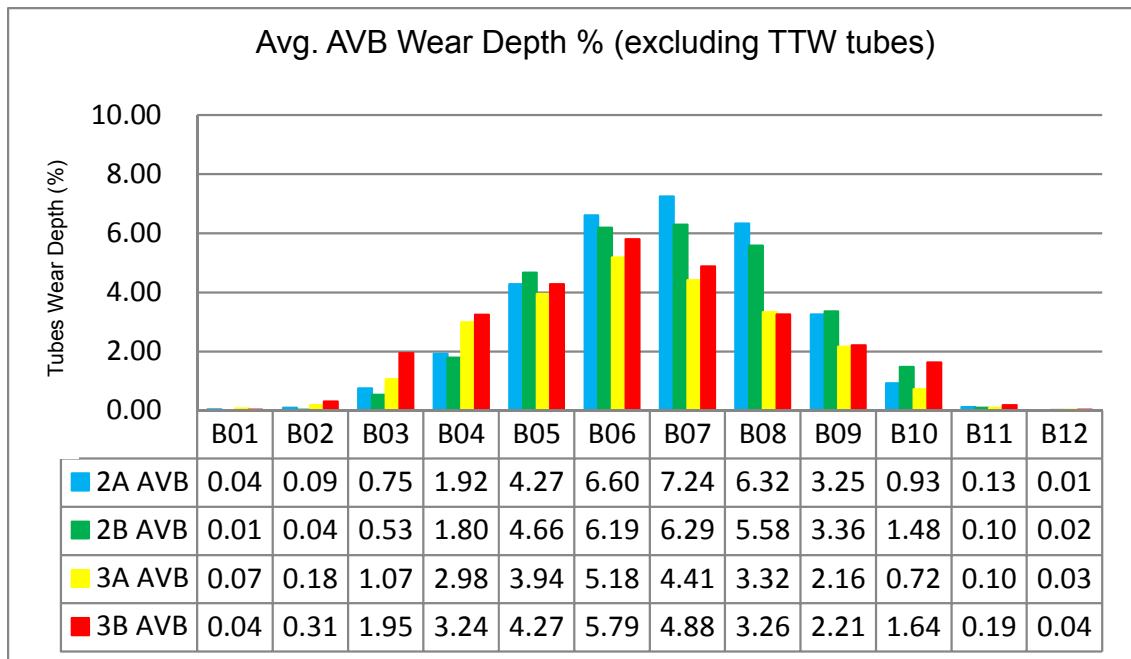
Figure 3.5-2 Tube Wear Depth Comparison

- 2) While the tube-to-AVB wear depth for tubes without in-plane TTW is greatest at the top of the tube bundle, the tube-to-AVB wear depths for tubes with in-plane TTW is almost uniformly distributed along the AVB intersections. (See Fig. 3.5-2.) If random vibration wear were a precursor for in-plane FEI wear, then the AVB wear for the tubes with in-plane FEI would be greatest at the top of the U-bends. But for TTW tubes, the average wear depth is almost the same in all AVB support locations and there is no tendency to concentrate at the top of the tube bundle.

- 3) The average 10% of AVB wear depth in Unit 2 and Unit 3 excluding TTW tubes is almost the same. (See Fig. 3.5-2.) Therefore, if random vibration were a precursor to in-plane FEI one would expect to see a similar number of tubes with tube-to-tube wear in the two RSG units. However, Unit 2 only has 2 tubes with TTW.

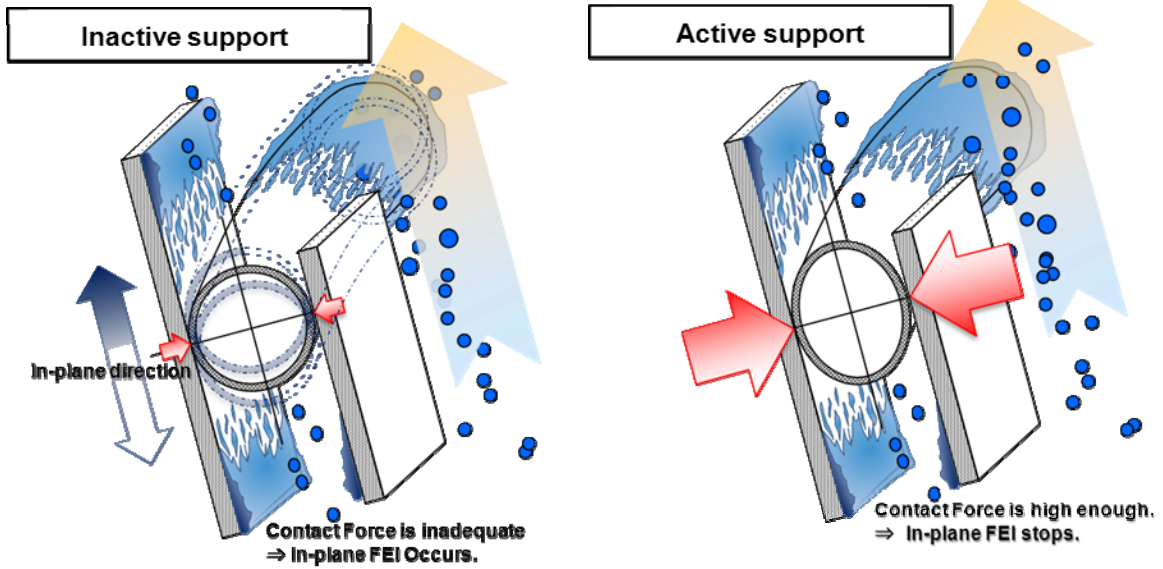
Fig. A2-1 Correlation between Number of inactive supports and Critical velocity

In the case of the SONGS RSGs, the number of active supports against out-of-plane FEI is considered to be the same as designed because narrow or effective zero gaps are confirmed by ECT measurements and visual inspection at tube-to-AVB intersections along representative tubes with wear. On the other hand, for tubes that exhibited tube-to-tube (Type-1) wear, the number of active supports against in-plane FEI is reduced because the contact force is not sufficient.

If the number of active supports that prevent in-plane FEI becomes sufficiently less than the number of supports that prevent out-of-plane FEI, the critical velocity of in-plane FEI becomes lower than that of out-of-plane FEI.
