trans alaska pipeline system

trans alaska pipeline system
2007

pipeline fast facts

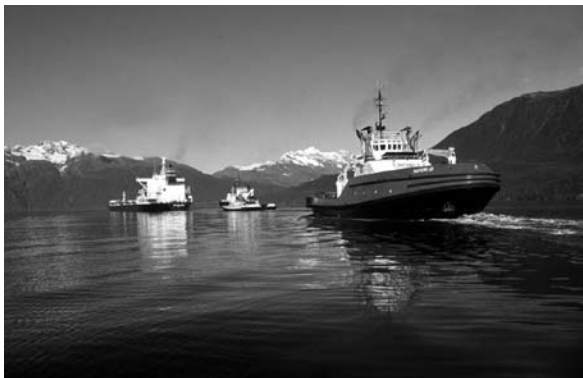
The *Tanerliq* (far right), one of two enhanced tractor tugs at the Valdez Terminal.

ENHANCED TRACTOR TUGS (ETT): *Nanuq* and *Tan'erliq* (Alaska Native words for "polar bear" and "black bear"). Designed for tethered tanker escort and oil spill response operations. The 153-foot vessels enhance SERVS' ability to assist a disabled tanker. The state-of-the-art vessels have exceptional maneuverability and were deployed in 1999.

- Crew: Seven trained response personnel.
- Firefighting: ABS Class 1 firefighting rating that includes pumps, monitors, foam and vessel spray system.
- Propulsion: Voith Schneider system; 10,192 hp.
- Spill Response Equipment:
 - 2,000 feet of oil containment boom.
 - DESMI skimmers.
 - 70,000 gallons of recovered oil storage capacity.
 - Dispersant spray arm systems.

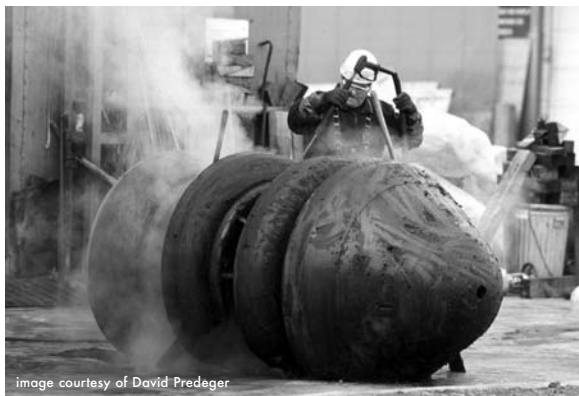
TAPS employee cleans a scraper pig at the Valdez Marine Terminal. Scraper pigs, which clean the pipeline and enhance oil flow, are pushed by the oil.

PIG: A mechanical device which is pushed through the pipeline by the oil. Consists of cone-shaped polyurethane cups on a central body which matches the shape of the interior pipe wall. Bumper nose, urethane construction and light weight prevent damage to check valve clappers. Several types of pigs are used to improve flow characteristics, inspect for dents and wrinkles, inspect for pipeline corrosion and measure pipeline curvature.

- **Batching:** Used during initial linefill.
- **Corrosion:** A pig which detects corrosion or pitting in the pipe wall. These pigs may use different technologies to collect and record corrosion data. First run in 1978.
 - **Magnetic:** Detects metal loss in pipe wall by measuring disturbances in a magnetic field. First run in 1978.
 - **Ultrasonic:** Measures and records wall thickness of pipeline using ultrasonic transducers. First run in June 1989.
- **Curvature:** A pig using an inertial navigation system to determine pipeline location, curvature and pipe wall deformation. First run in 1992.
- **Deformation:** A pig which measures the diameter of the pipe. Defines changes in pipe diameter caused by dents, ovalities, or pipe bending. Changes are recorded and analyzed by engineers. First run in 1979.
- **Scraper:** A pig used for cleaning and flow enhancement. First run in 1977.

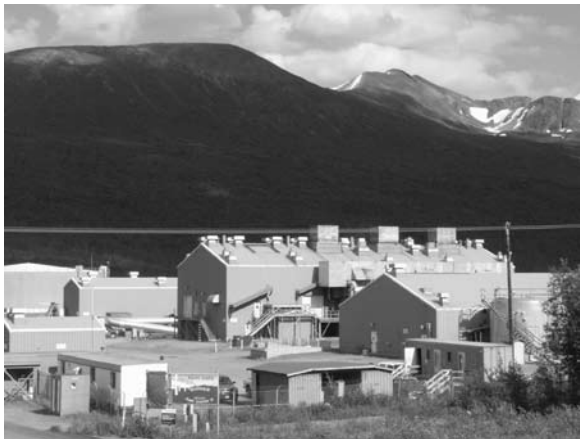
Pump Station 12, 65 miles north of Valdez, is in the southernmost station, pushing the oil up and over Thompson Pass.
